## Clearwater Beach Island Coastal Management History

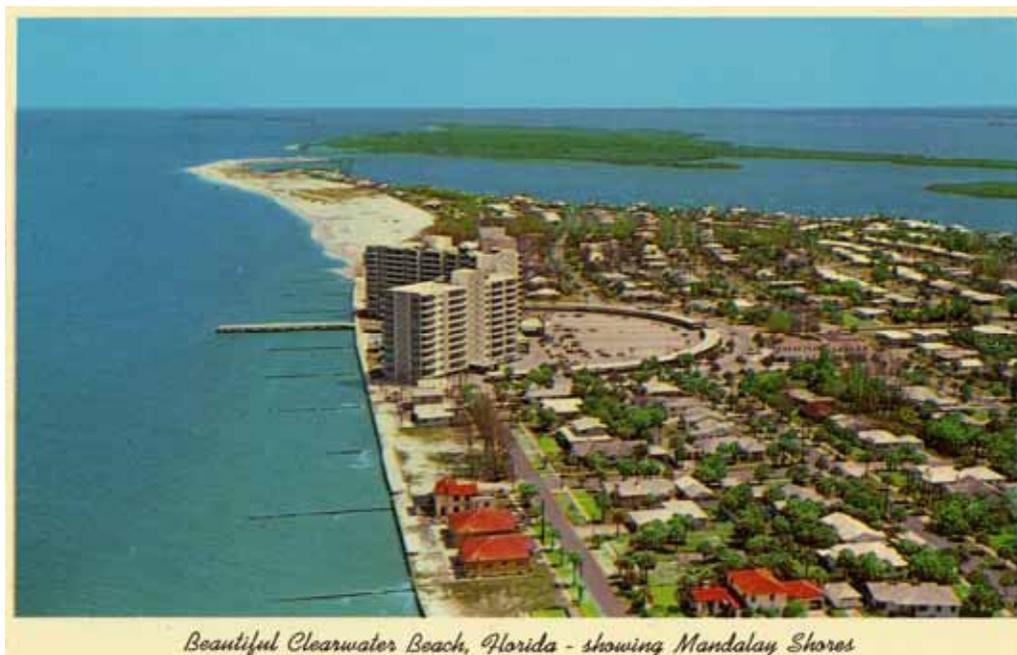
By 1961, the city had built a total of 25 groins along the island including a short terminal groin at the south end of the island. The city also built two concrete-slab baffle piers, one of which fronts the Mandalay Condos, shown in this 1960 postcard image. Most of the length of the beach was lined with seawalls.

The photo below was taken at the end of September 2004, after the worst hurricanes in at least a decade. It illustrates that the beaches are significantly wider than in the 1960's, compare to this 1960 postcard above (same condo).

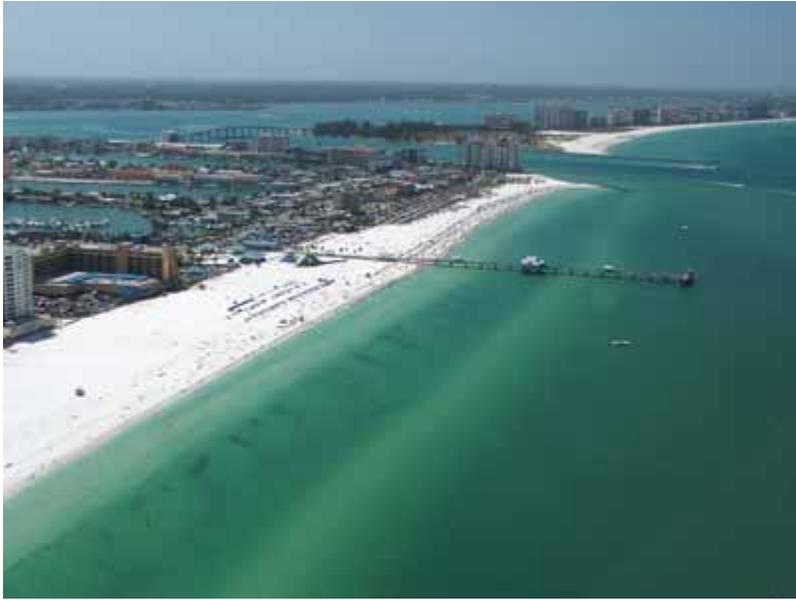
Thanks to the erosion control measures taken by the city, Clearwater Beach is now a beautiful fine white native sand beach that does not require nourishment. The photo below looks south along Clearwater Beach during the spring of 2006.
