Clearwater Pass Coastal Management History

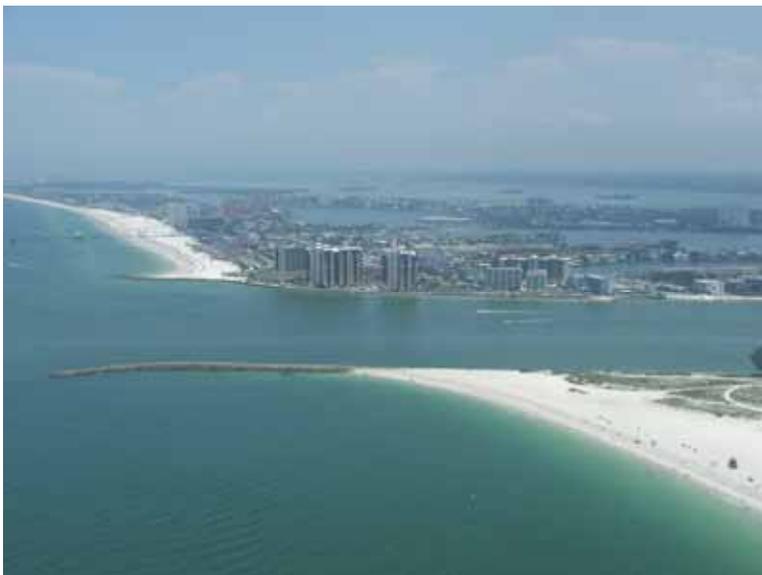
The photo below looks north at Clearwater Pass during the spring of 2005.

Known as Little Pass in the late 1800's, **Clearwater Pass** was only about 100 m wide. As a result of the hurricane of 1921, "Little Pass" increased to over ½ mile wide (see [Clearwater Beach Island](#)). From the 1930's to the 70's, the channel narrowed as it came back into equilibrium with the tidal prism. Clearwater Pass was being constricted by sediment input from the south as Sand Key extended to the north. As a result of this narrowing, the channel deepened to carry its large tidal prism. Between 1962 and 1973, the channel's depth increased from 10 to 20 ft. The existing bridge pilings began to scour at the base, threatening the structure. To stop further constriction, the ½ mile-long south jetty was completed in 1975 and successfully stabilized Clearwater Pass.
