# The History of PINELLAS COUNTY'S FEDERAL SHORE PROTECTION PROJECT

**Field Trip Guidebook** for the American Shore and Beach Preservation Association (**ASBPA**) 2009 National Coastal Conference

ST. PETE BEACH, FL | OCTOBER 16, 2009

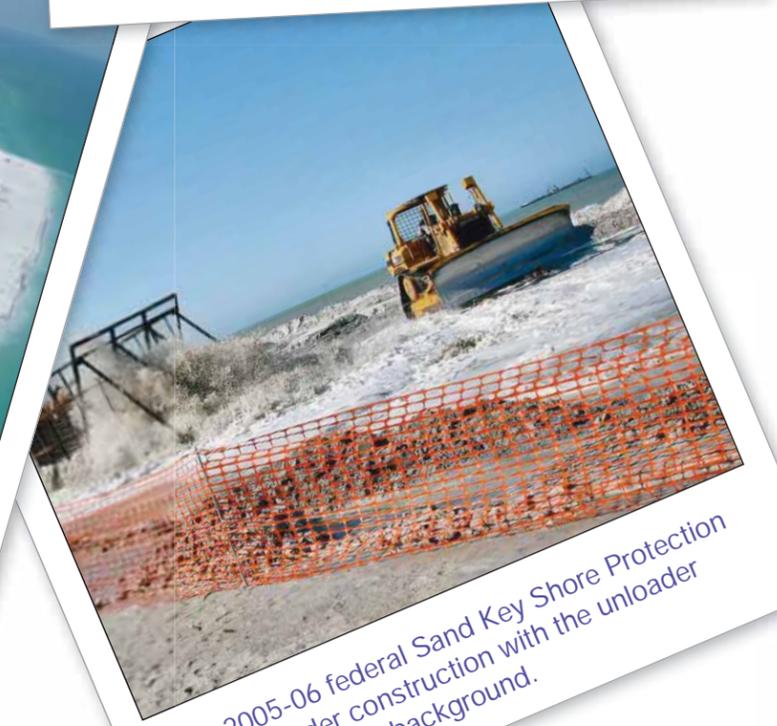
Clearwater and Belleair Beach segments of the 2005-06 federal Sand Key Shore Protection Project under construction.

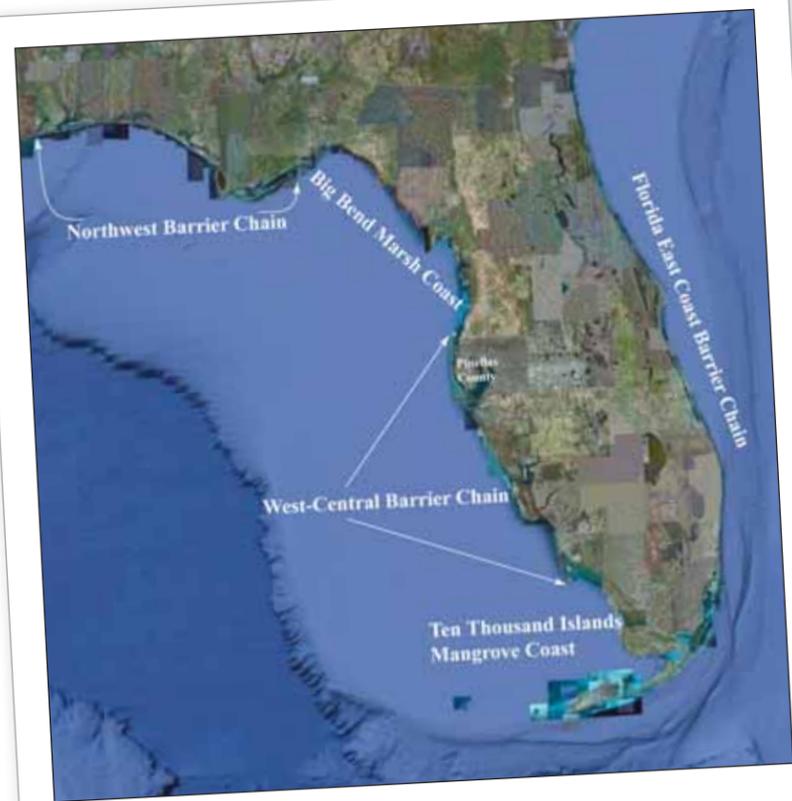
Google Earth satellite image of Florida showing the coastal provinces of Florida

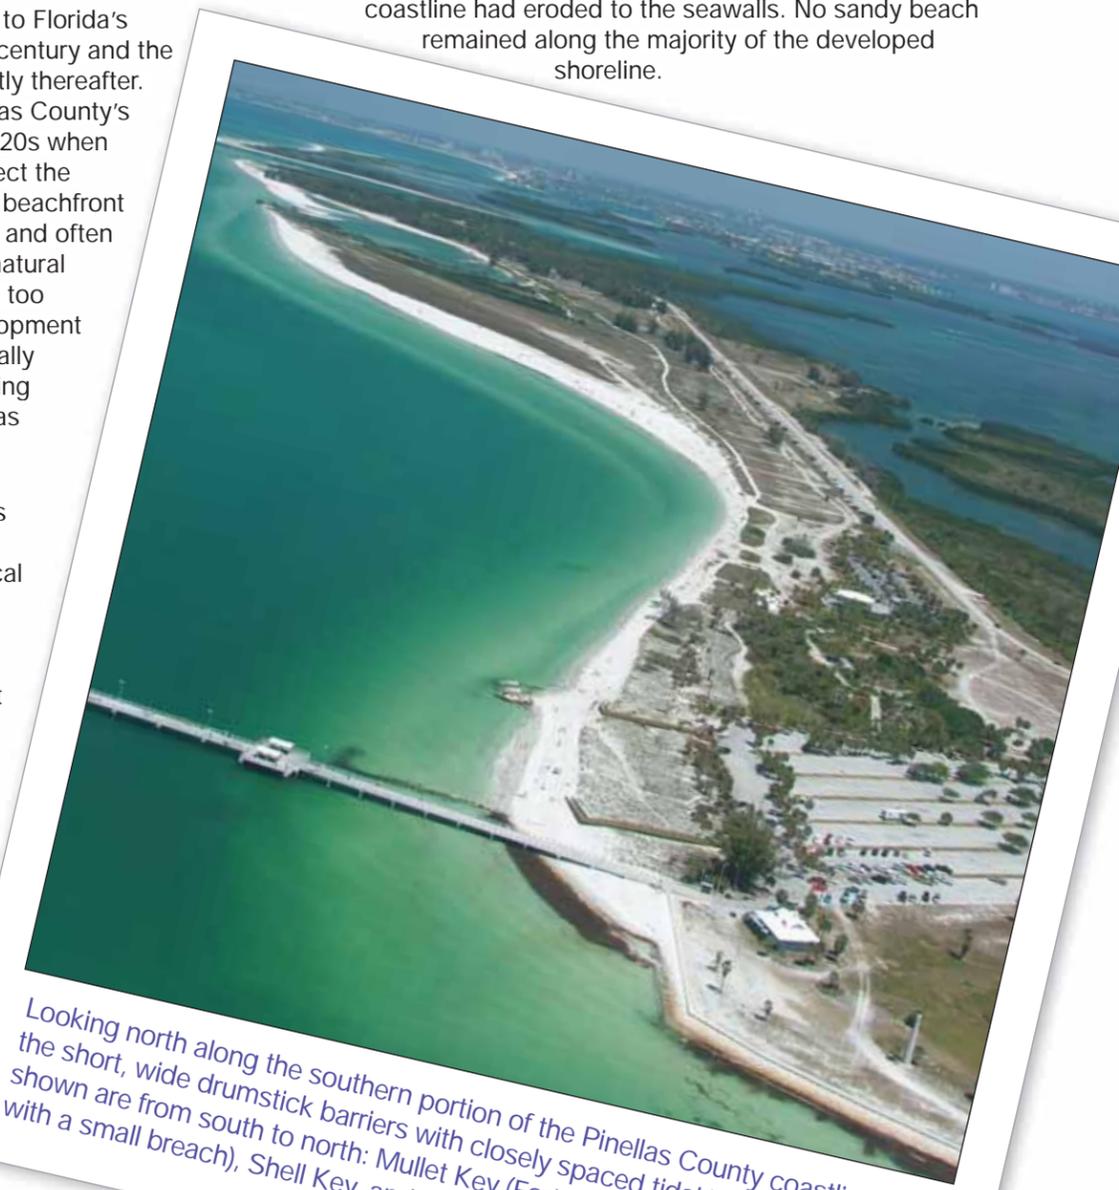
Looking north along the southern portion of the Pinellas County coastline at the short, wide drumstick barriers with closely spaced tidal inlets. The barriers shown are from south to north: Mullet Key (Fort De Soto Park, shown here with a small breach), Shell Key, and Long Key (distant background).

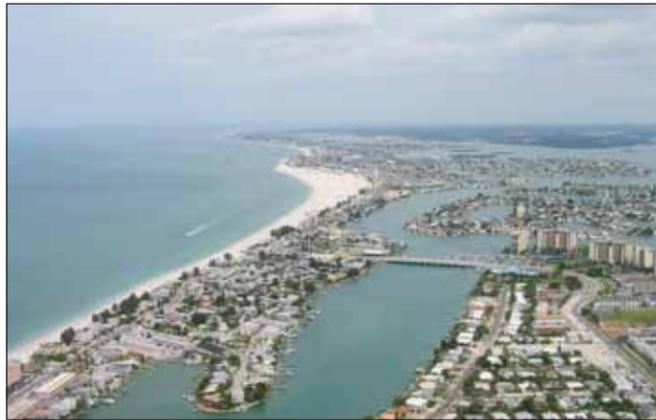
Southern Pinellas County's 1960s-era dredge-and-fill construction in Boca Ciega Bay

Dredge-and-fill construction during the construction boom that began in the mid-1950s reduced the surface area of the back-barrier bays. This reduced the tidal prisms of the inlets. As a result of both causeway and dredge-and-fill construction prior to the 1975 Fill Act, the surface area of Boca Ciega Bay decreased by nearly 30 percent (Mehta et. al, 1976). During the late 19th century, both John's Pass and Blind Pass had similar cross-sectional areas, but by the mid-20th century, they had diverged significantly due to both natural and human intervention.

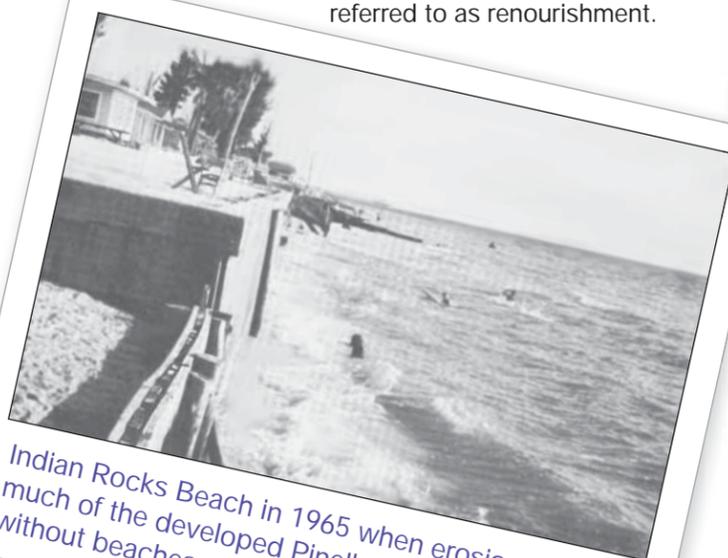
Indian Rocks Beach in 1965 when erosion had left much of the developed Pinellas County shoreline without beaches

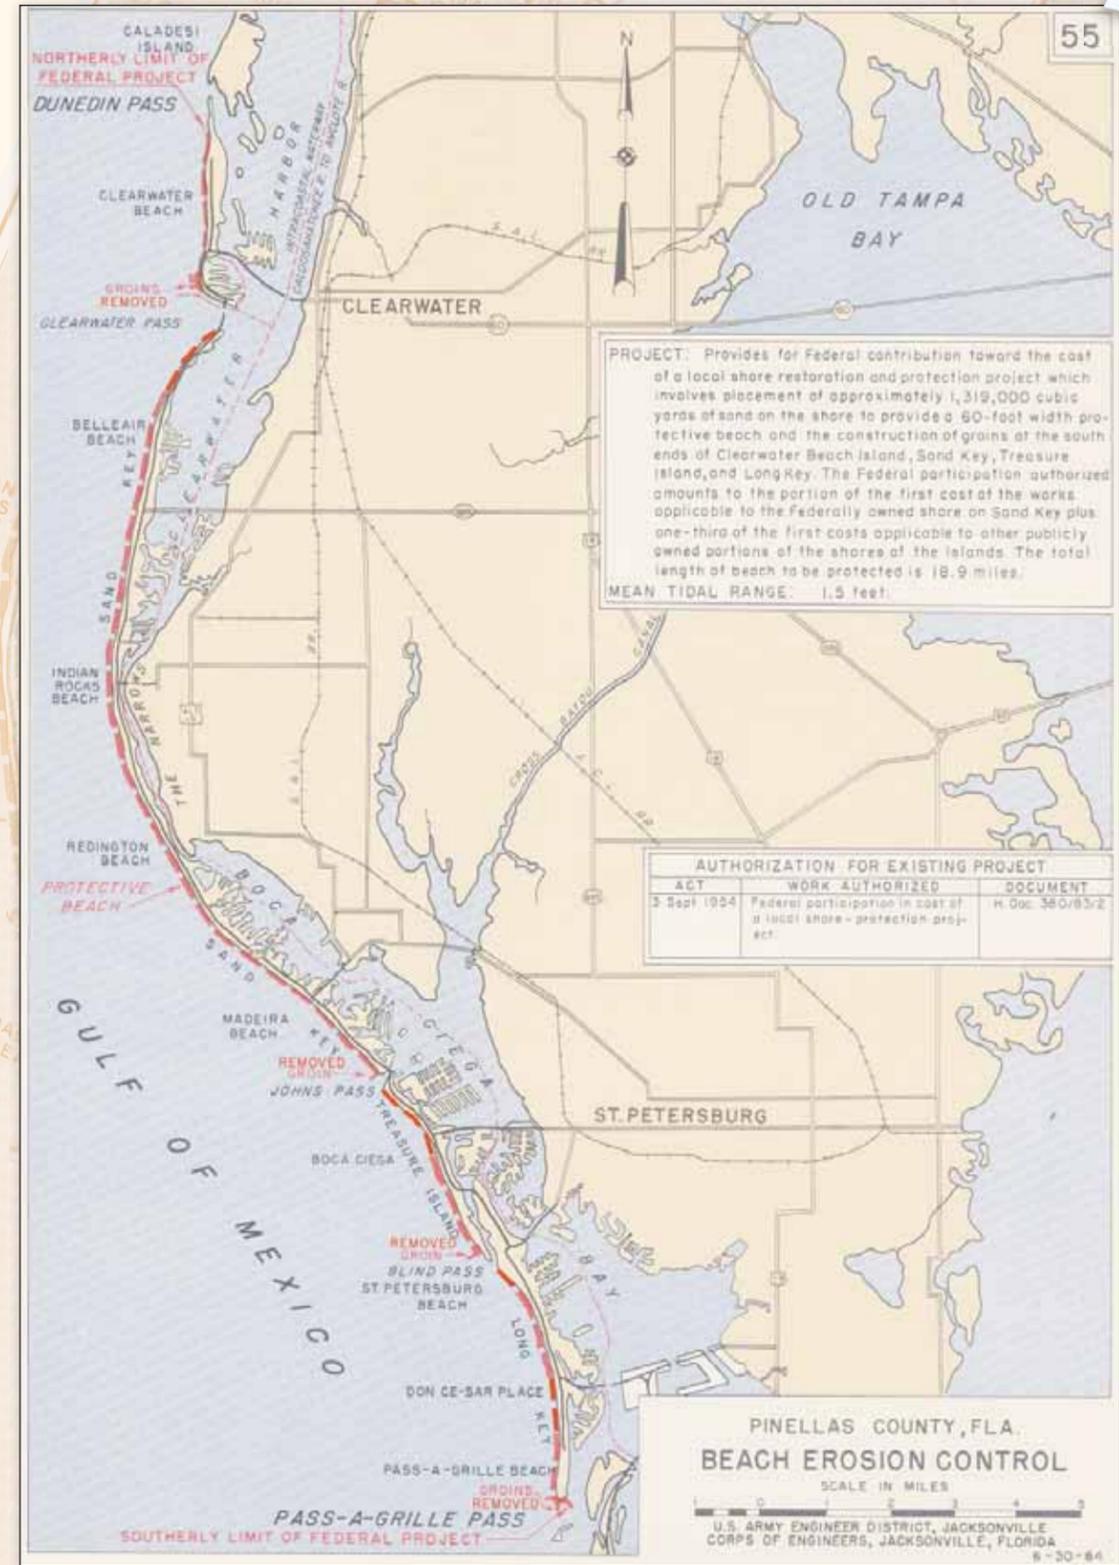
Pinellas County's federally authorized project area, 1966

A federal shore protection project was initiated along 100 percent of Pinellas County's developed shoreline in 1966 (see map, page 7). The project includes the developed barrier islands of Clearwater Beach, Sand Key, Treasure Island and Long Key (the latter three are the active projects). No structures were approved for inclusion in this project.

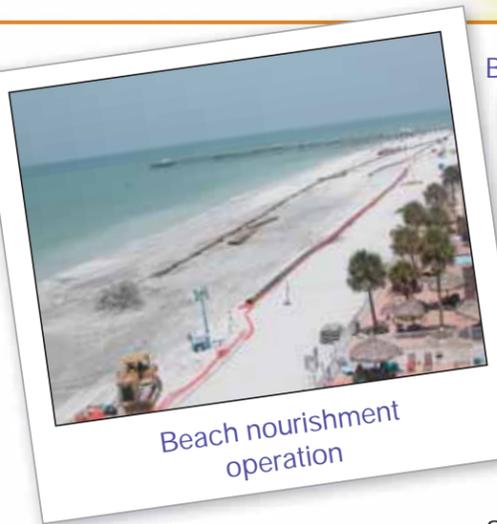
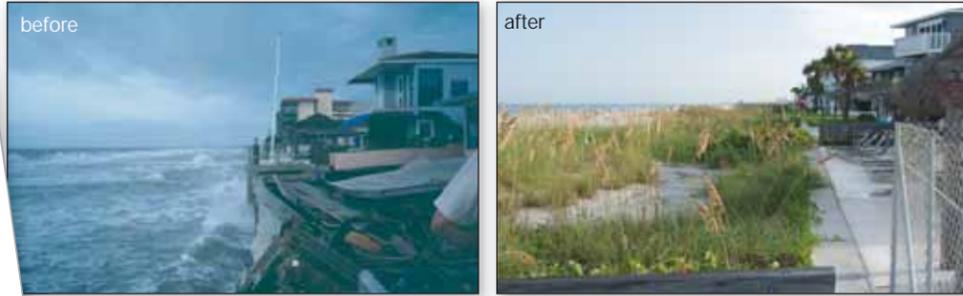
Beach nourishment operation

Belleair Beach (Sand Key segment, Pinellas County SPP) before and after nourishment

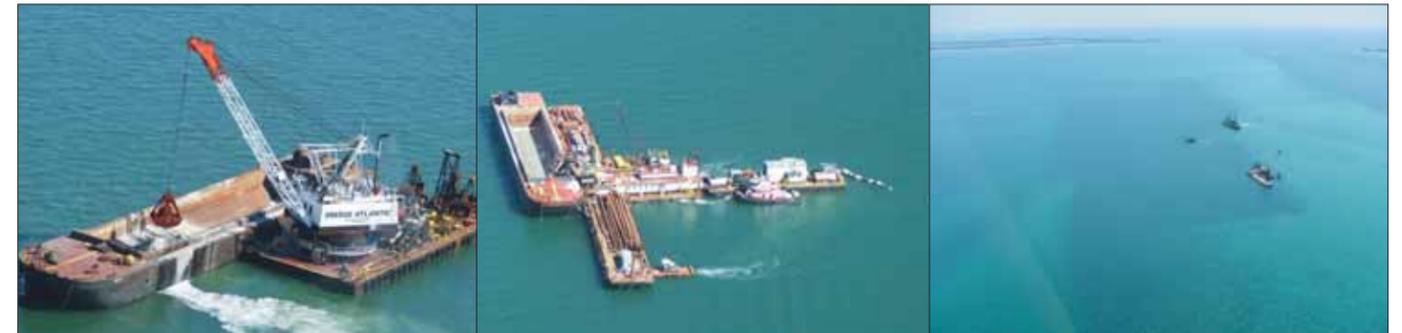
The bucket dredge Atlantic loading a scow in the Egmont Shoal in 2005. The unloader Vicksburg unloading a scow offshore of Sand Key in 2005.

The largest borrow area in Pinellas County is the Egmont Channel Shoal. Due to its distance from the beach project areas and the shallow nearshore waters of Pinellas County, the Egmont Shoal is dredged with either a bucket or cutterhead dredge. The dredges load scows, or sand barges, which are pushed to the beach project area with tugboats. Once offshore of the beach, the scows are hooked up to an unloader that pumps the sand through a submerged pipeline to the beach. This operation was most recently conducted in 2005-06.

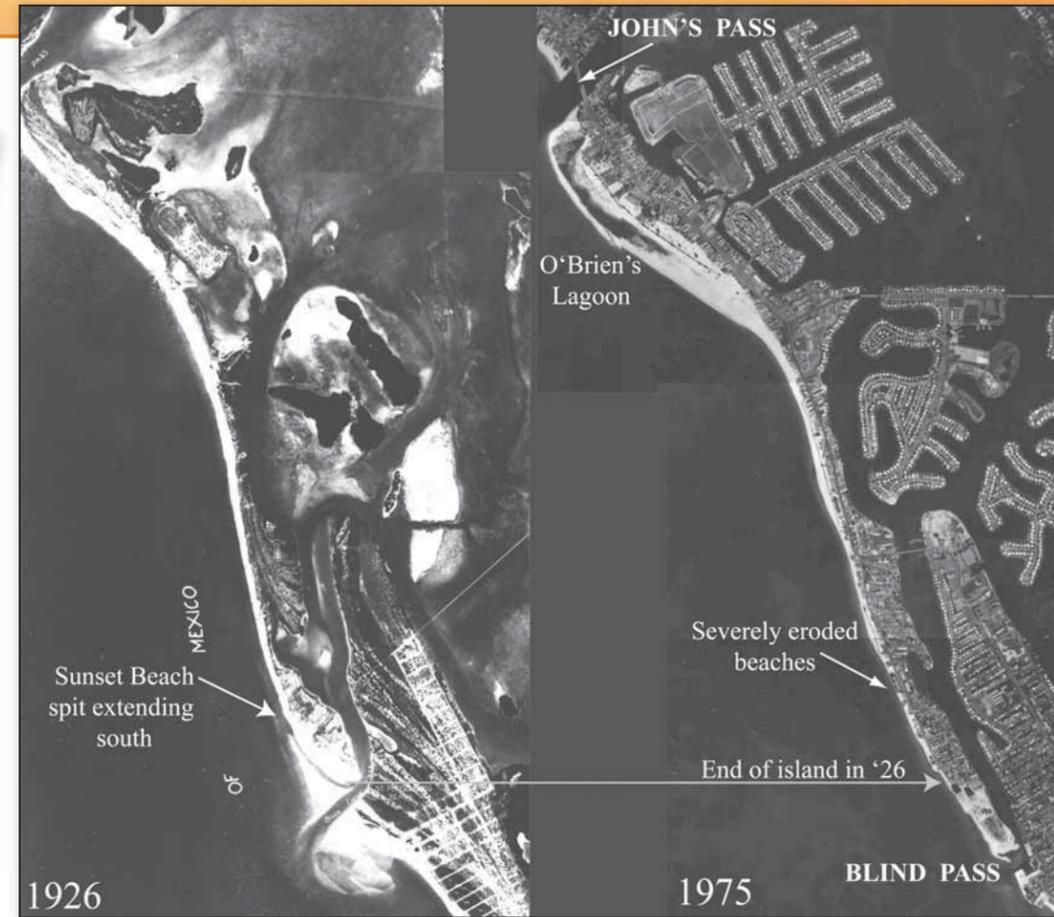
Historical aerial photos of Treasure Island in 1926 and 1975 illustrating the morphologic evolution of the island, including the migration of Blind Pass and the formation of O'Brien's Lagoon.

½ mile south of John's Pass. The combined length of the islands was more than a mile shorter than the present length of the barrier. By 1926, the islands had coalesced and Treasure Island was elongating to the south due to the destabilization and southerly migration of Blind Pass.

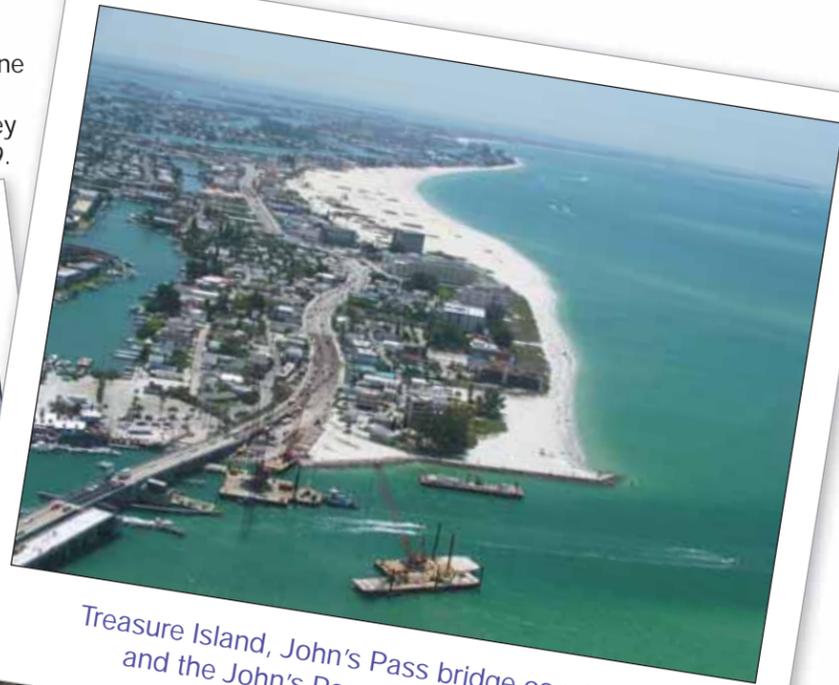
Treasure Island, John's Pass bridge construction and the John's Pass south terminal groin

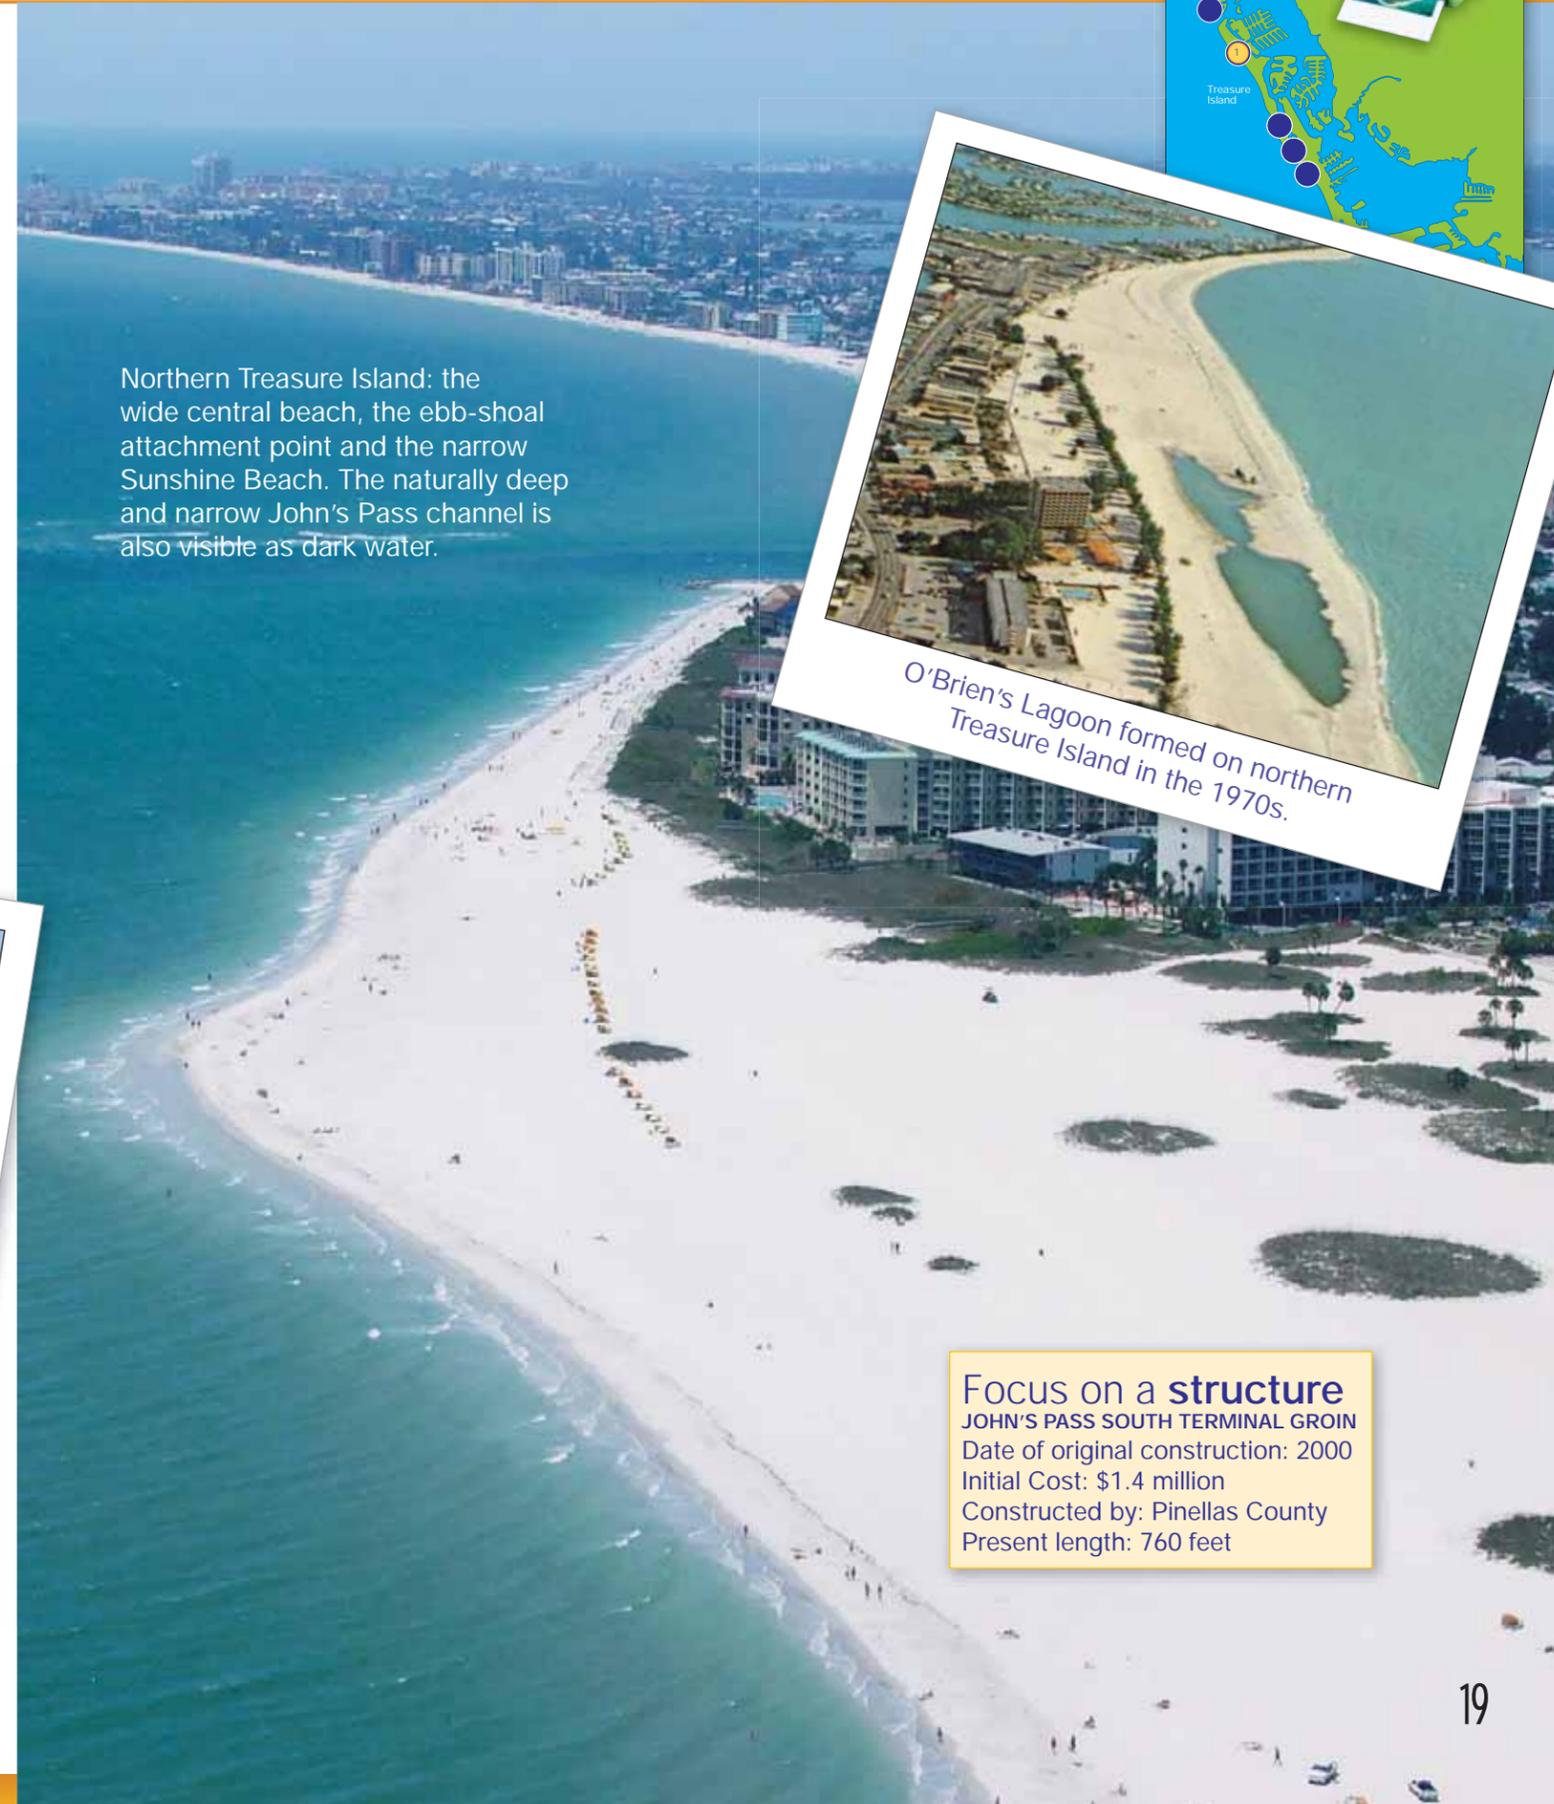
Northern Treasure Island: the wide central beach, the ebb-shoal attachment point and the narrow Sunshine Beach. The naturally deep and narrow John's Pass channel is also visible as dark water.

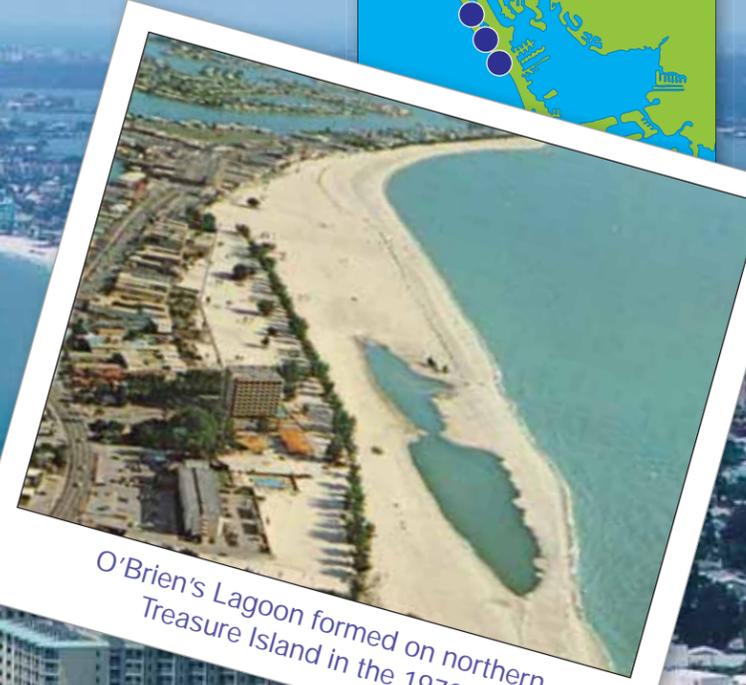
O'Brien's Lagoon formed on northern Treasure Island in the 1970s.

When federally authorized dredging of John's Pass began in 1966, over 77,000 cubic yards of dredge spoil was placed nearly four miles offshore of Sunshine Beach in a spoil site that was used to dispose of nearly 100,000 cubic yards in 1960. The material amalgamated into a huge, concave-shoreward sand bar (more than 1/2 mile long) and attached to the north shore of the barrier in 1968. Over the next few years, the bar consolidated and became impervious to tidal flux or overtopping by regular wave energy. Thus, a small-scale lagoon formed and was named O'Brien's Lagoon after the Dean of the University of Florida's coastal engineering program, M.P. O'Brien. Many of the 1971 through 1983 federal projects involved either excavating sand from or attempting to fill the lagoon.

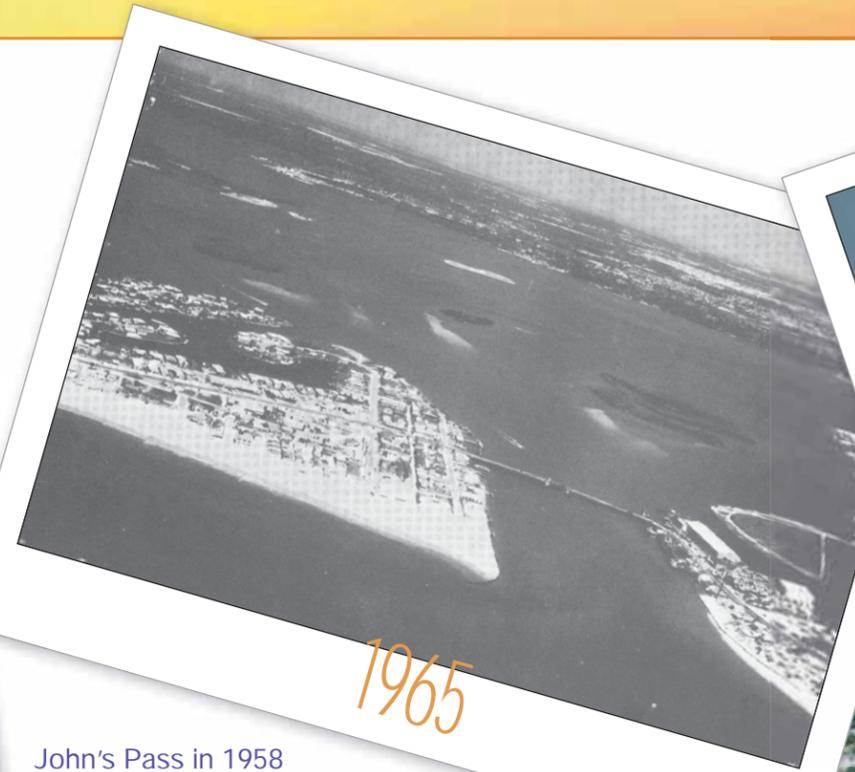
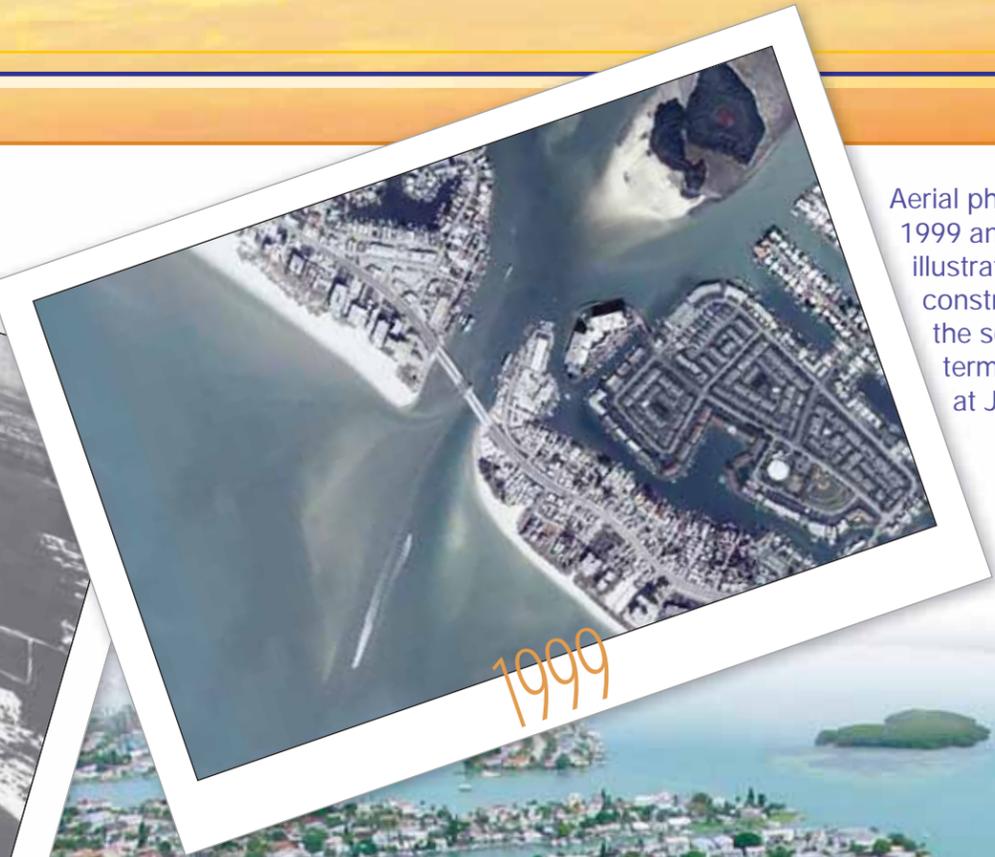
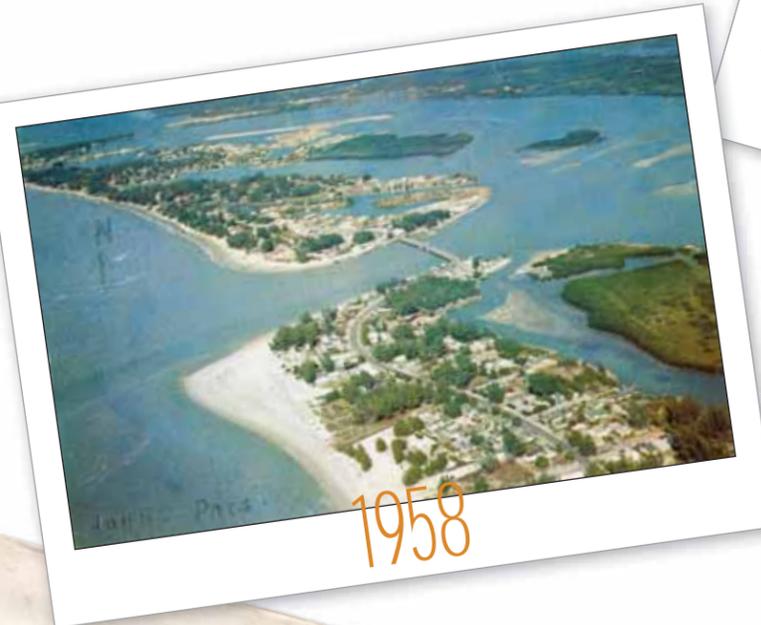
Aerial photos from 1999 and 2002 illustrating the construction of the southern terminal groin at John's Pass

John's Pass in 1958 with eroded beach on the north side of the inlet, and in 1965, after construction of the north terminal groin.

In 2000, Pinellas County constructed another terminal groin on the south side of John's Pass. John's Pass will be dredged as one of the borrow areas for the Treasure Island/Long Key segment of the Pinellas County SPP in the fall of 2009.

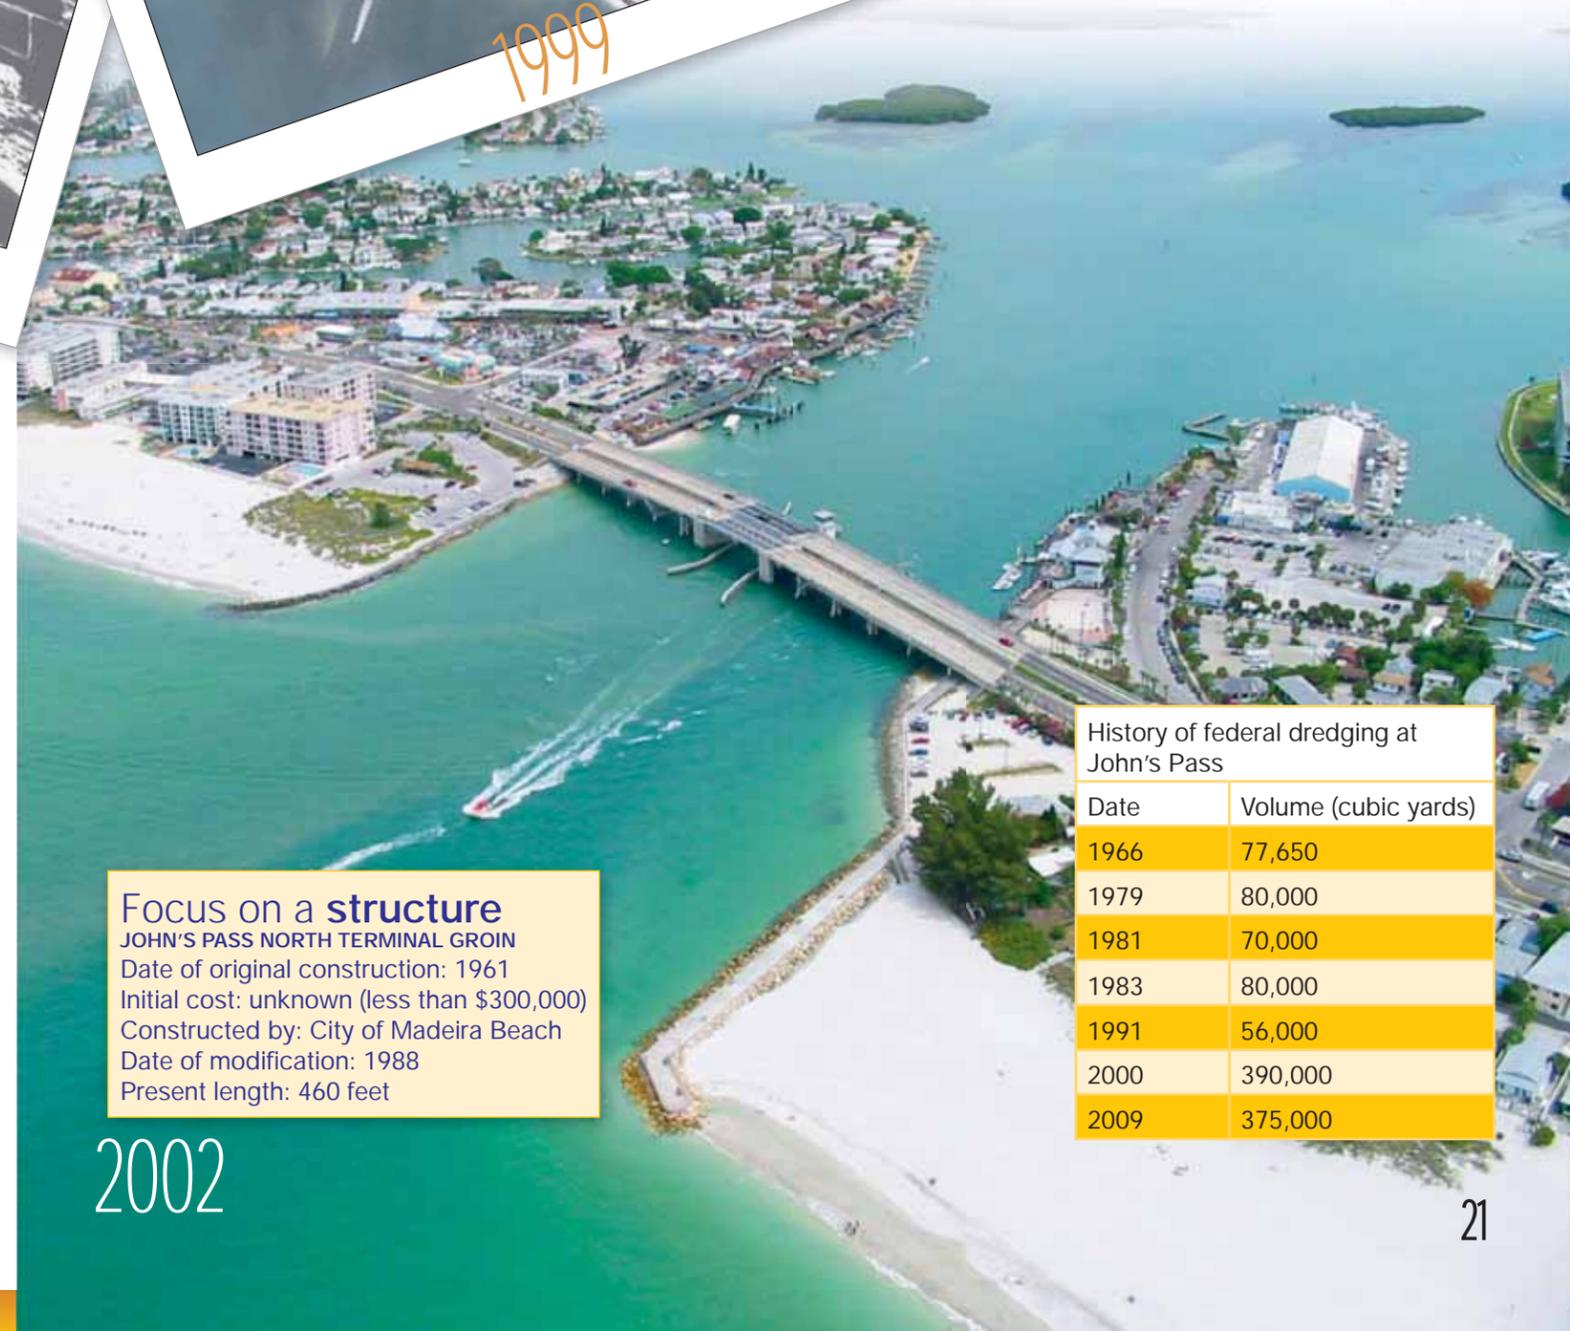
**Focus on a structure**  
**JOHN'S PASS NORTH TERMINAL GROIN**  
 Date of original construction: 1961  
 Initial cost: unknown (less than \$300,000)  
 Constructed by: City of Madeira Beach  
 Date of modification: 1988  
 Present length: 460 feet

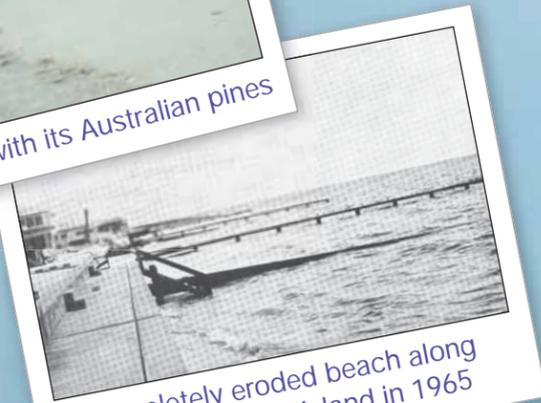
Completely eroded beach along central Treasure Island in 1965

Unregulated coastal development, which included dredge-and-fill construction in the back-barrier bays, led to significant beach erosion in the mid-20th century. In an effort to curb erosion, the City of Treasure Island constructed 56 ineffective groins in 1960 along the "severely eroded beaches." The complete lack of a beach was in direct contrast to the large volumes of sand that supplied the island during the early 1900s.

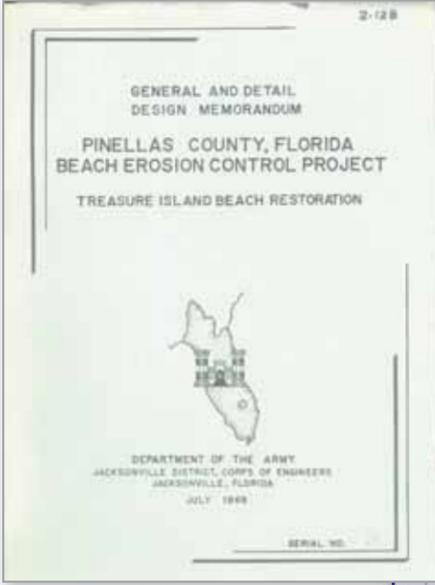
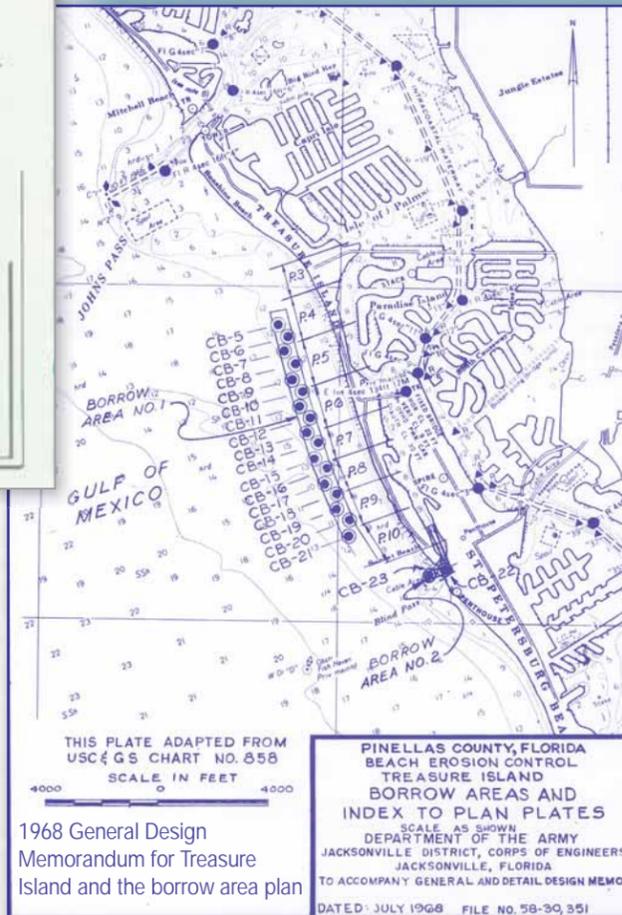
1968 General Design Memorandum for Treasure Island and the borrow area plan

As explained earlier, the federal government authorized the Pinellas County SPP in 1966. The U.S. Army Corps of Engineers first addressed Treasure Island by publishing a General Design Memorandum in 1968. The GDM recommended the use of a shore-parallel borrow pit as the sand source for nourishment of the southern beaches. This was a common practice in the 1960s. The shore-parallel pit was a cheap and efficient way to build a beach, and it was an improvement over dredging the productive mangrove and tidal flat ecosystems in the back barrier bays. Constructed in 1969, Treasure Island was the first federal nourishment project on the west coast of Florida.

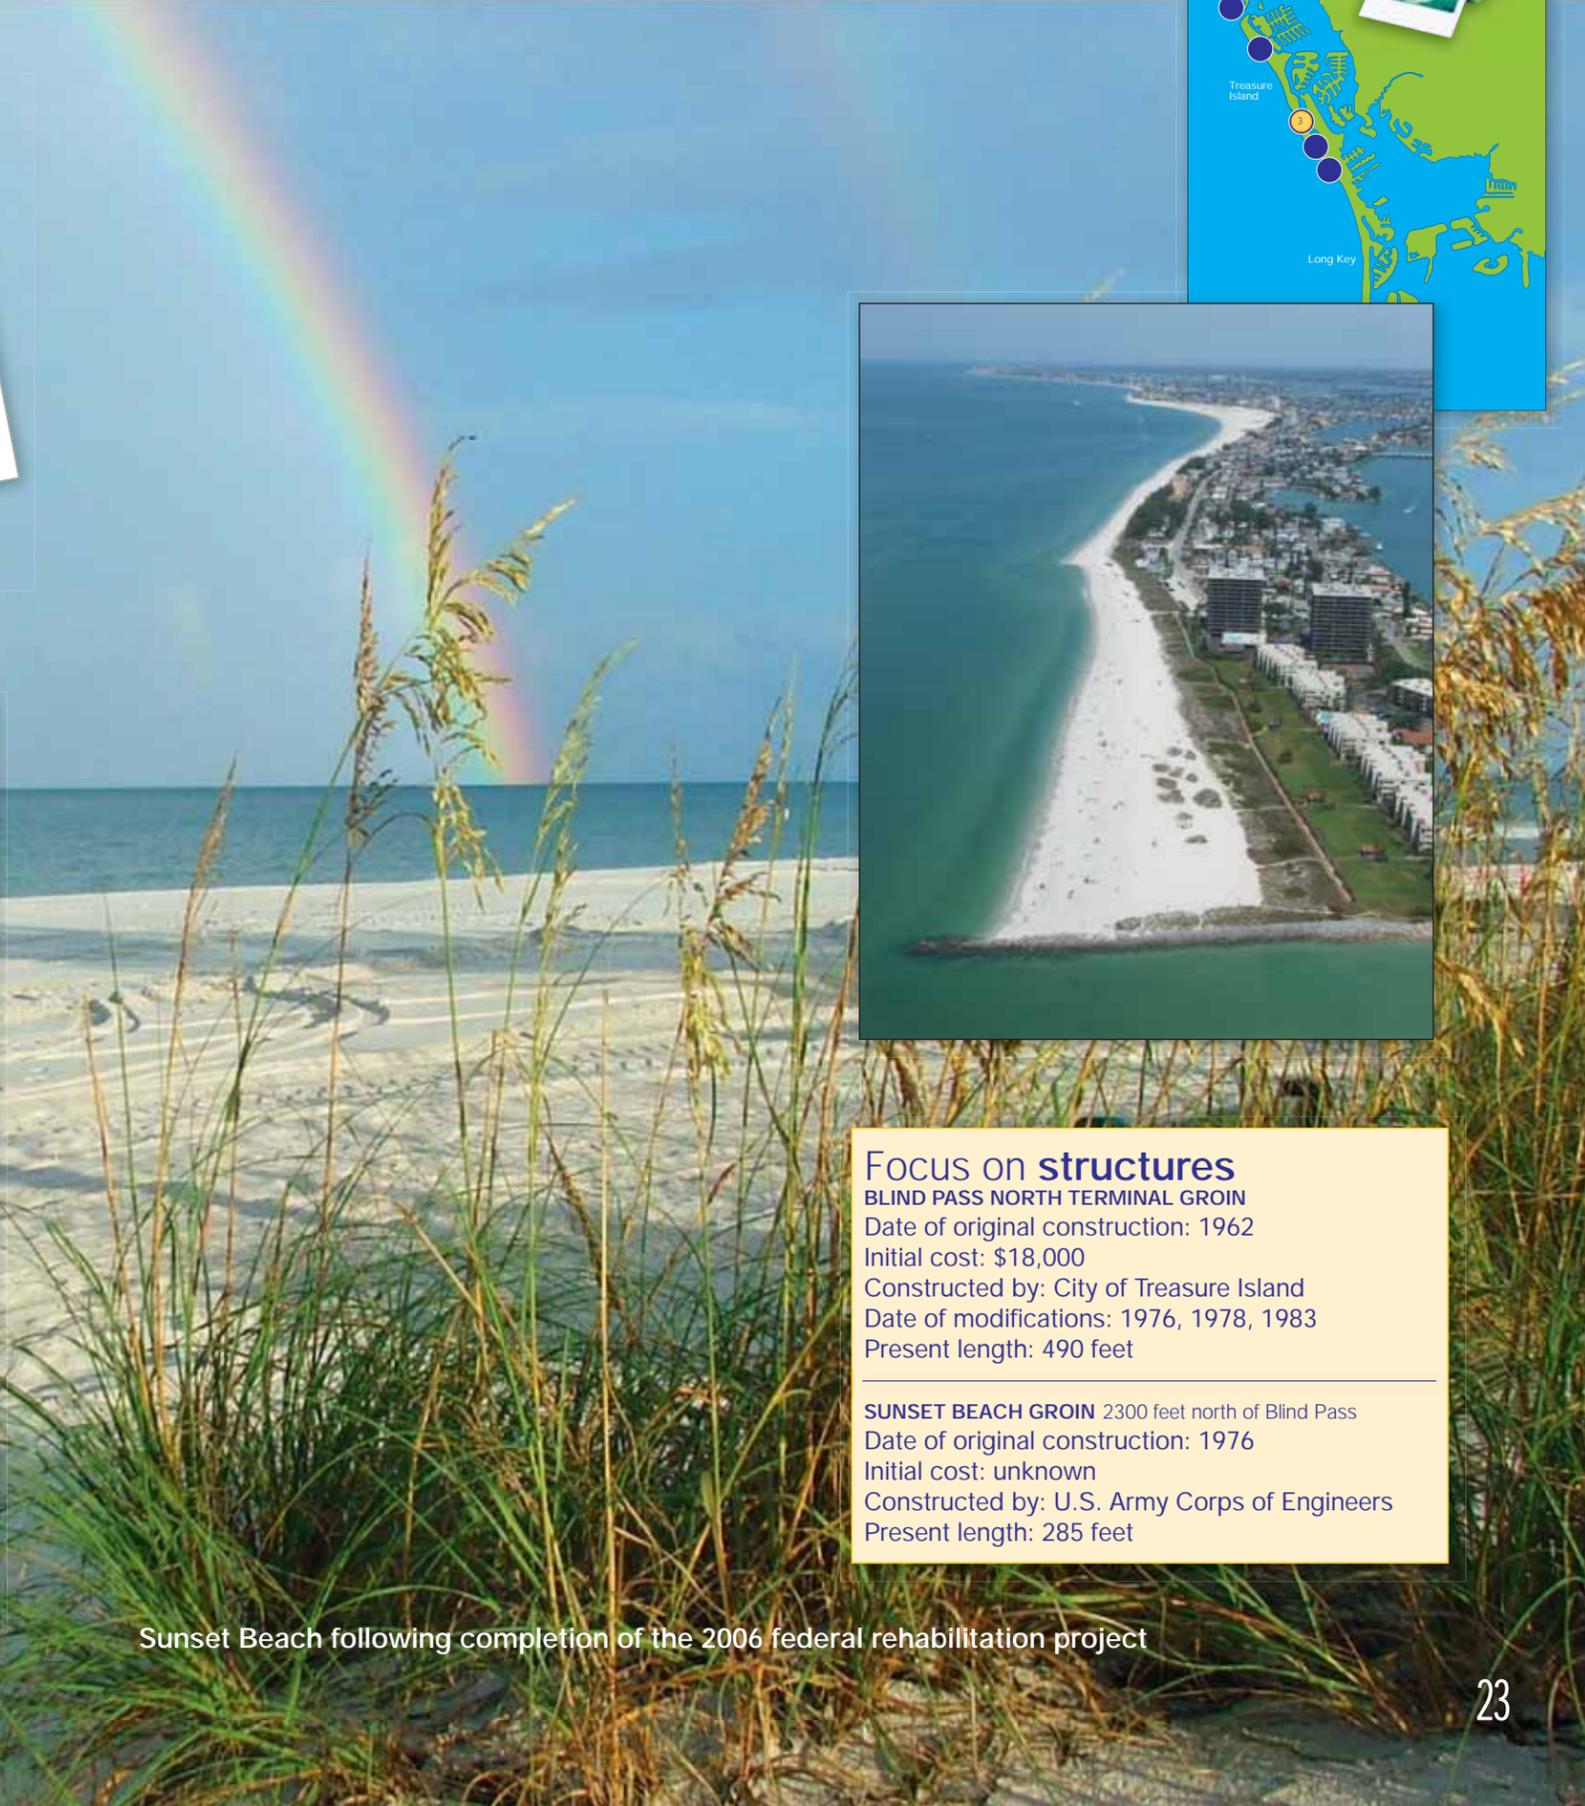
**Focus on structures**  
**BLIND PASS NORTH TERMINAL GROIN**  
 Date of original construction: 1962  
 Initial cost: \$18,000  
 Constructed by: City of Treasure Island  
 Date of modifications: 1976, 1978, 1983  
 Present length: 490 feet

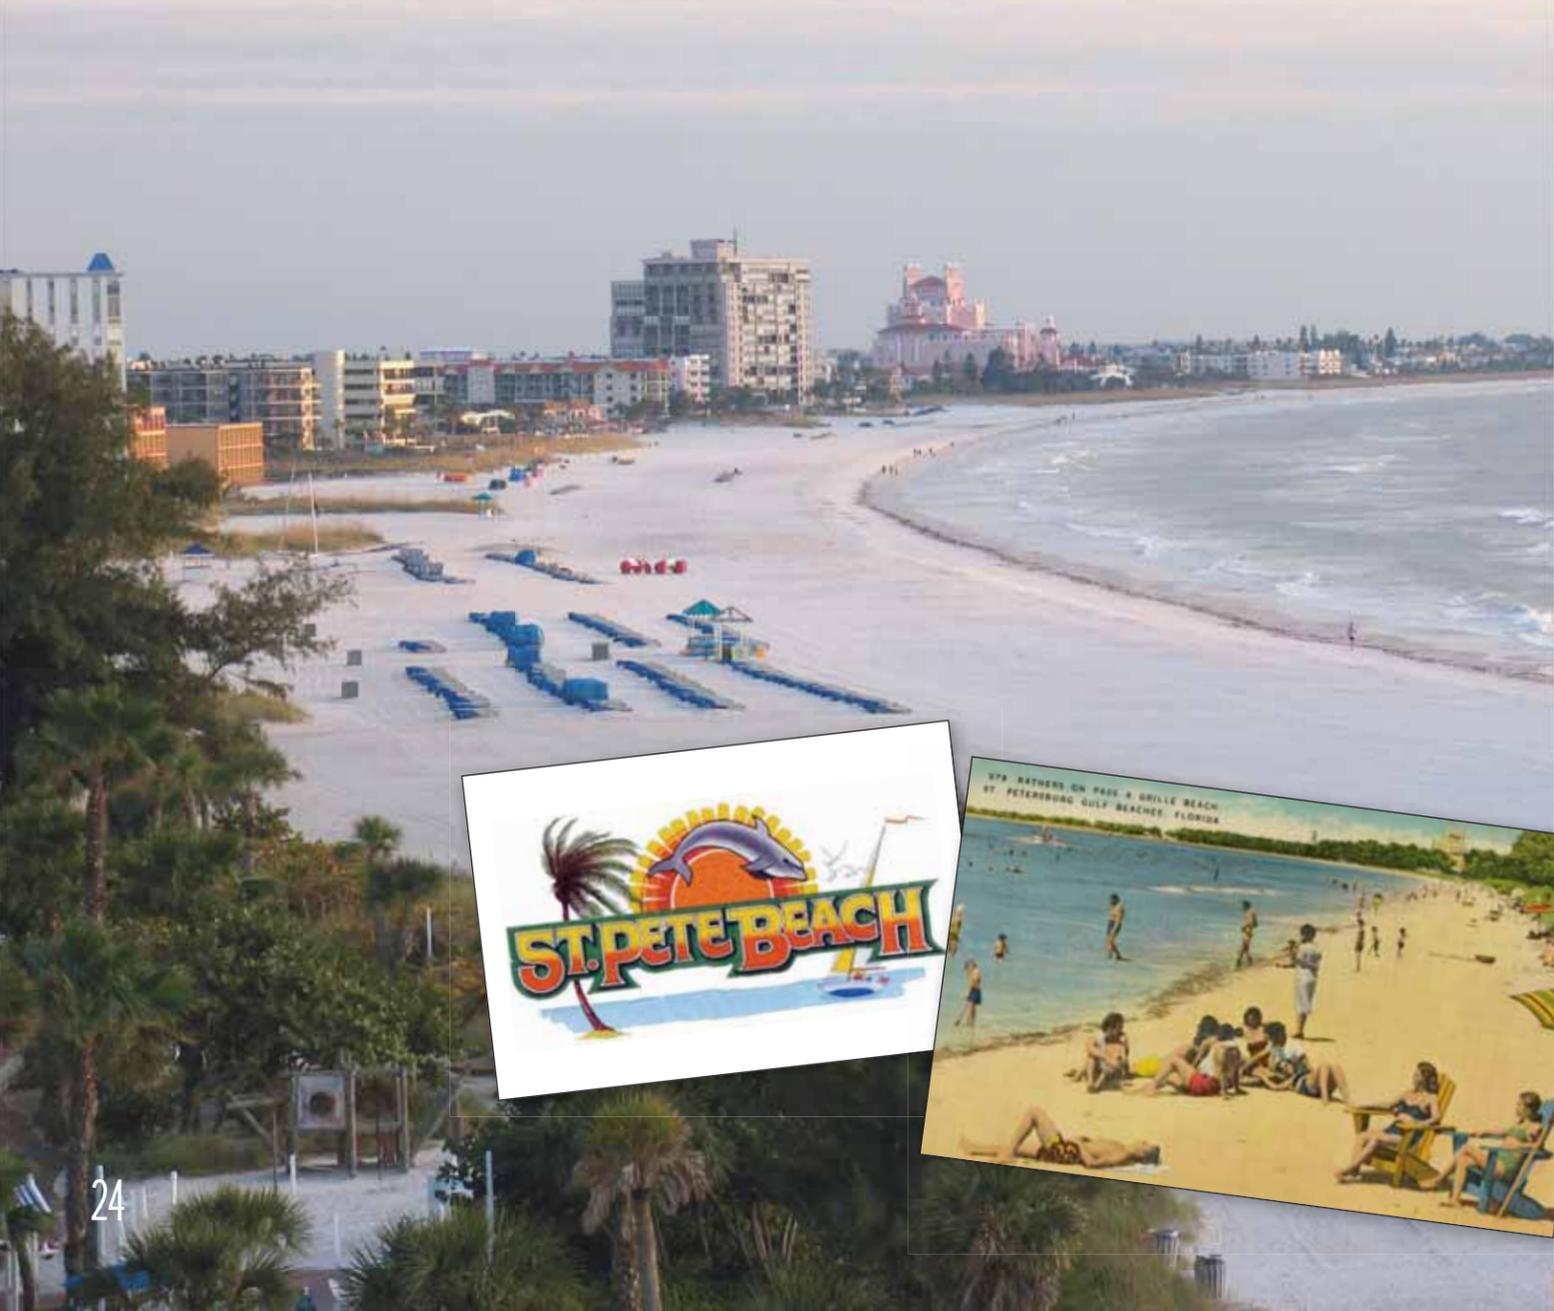
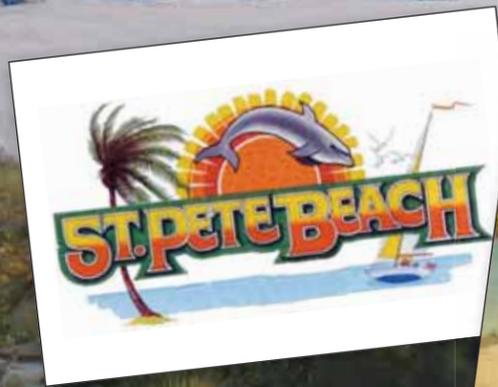
1873 Historic T-sheet and 1926 aerial photo illustrating the morphologic evolution of Long Key
