# The History of PINELLAS COUNTY'S FEDERAL SHORE PROTECTION PROJECT

**Field Trip Guidebook** for the American Shore and Beach Preservation Association (**ASBPA**) 2009 National Coastal Conference

ST. PETE BEACH, FL | OCTOBER 16, 2009

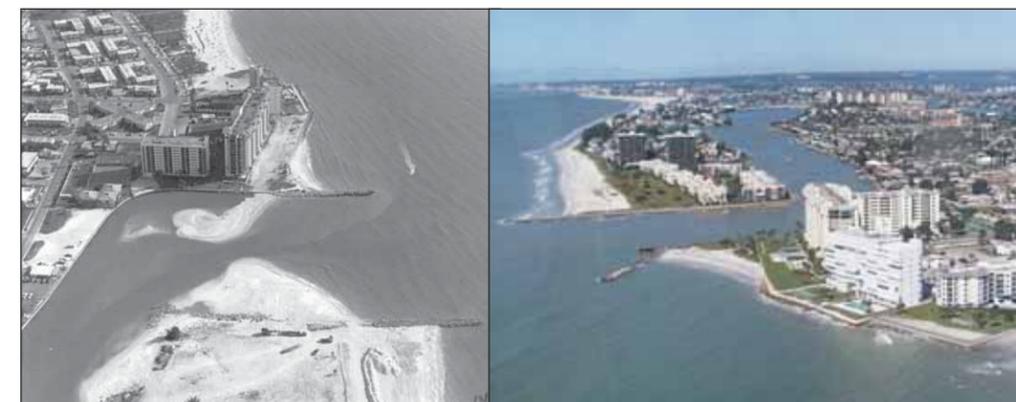
Looking south along Long Key at Blind Pass shoaling in December 1978

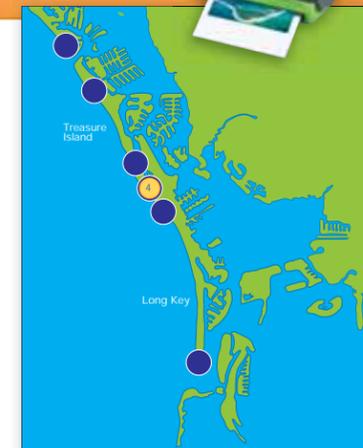
Blind Pass ebb shoal, August 2008

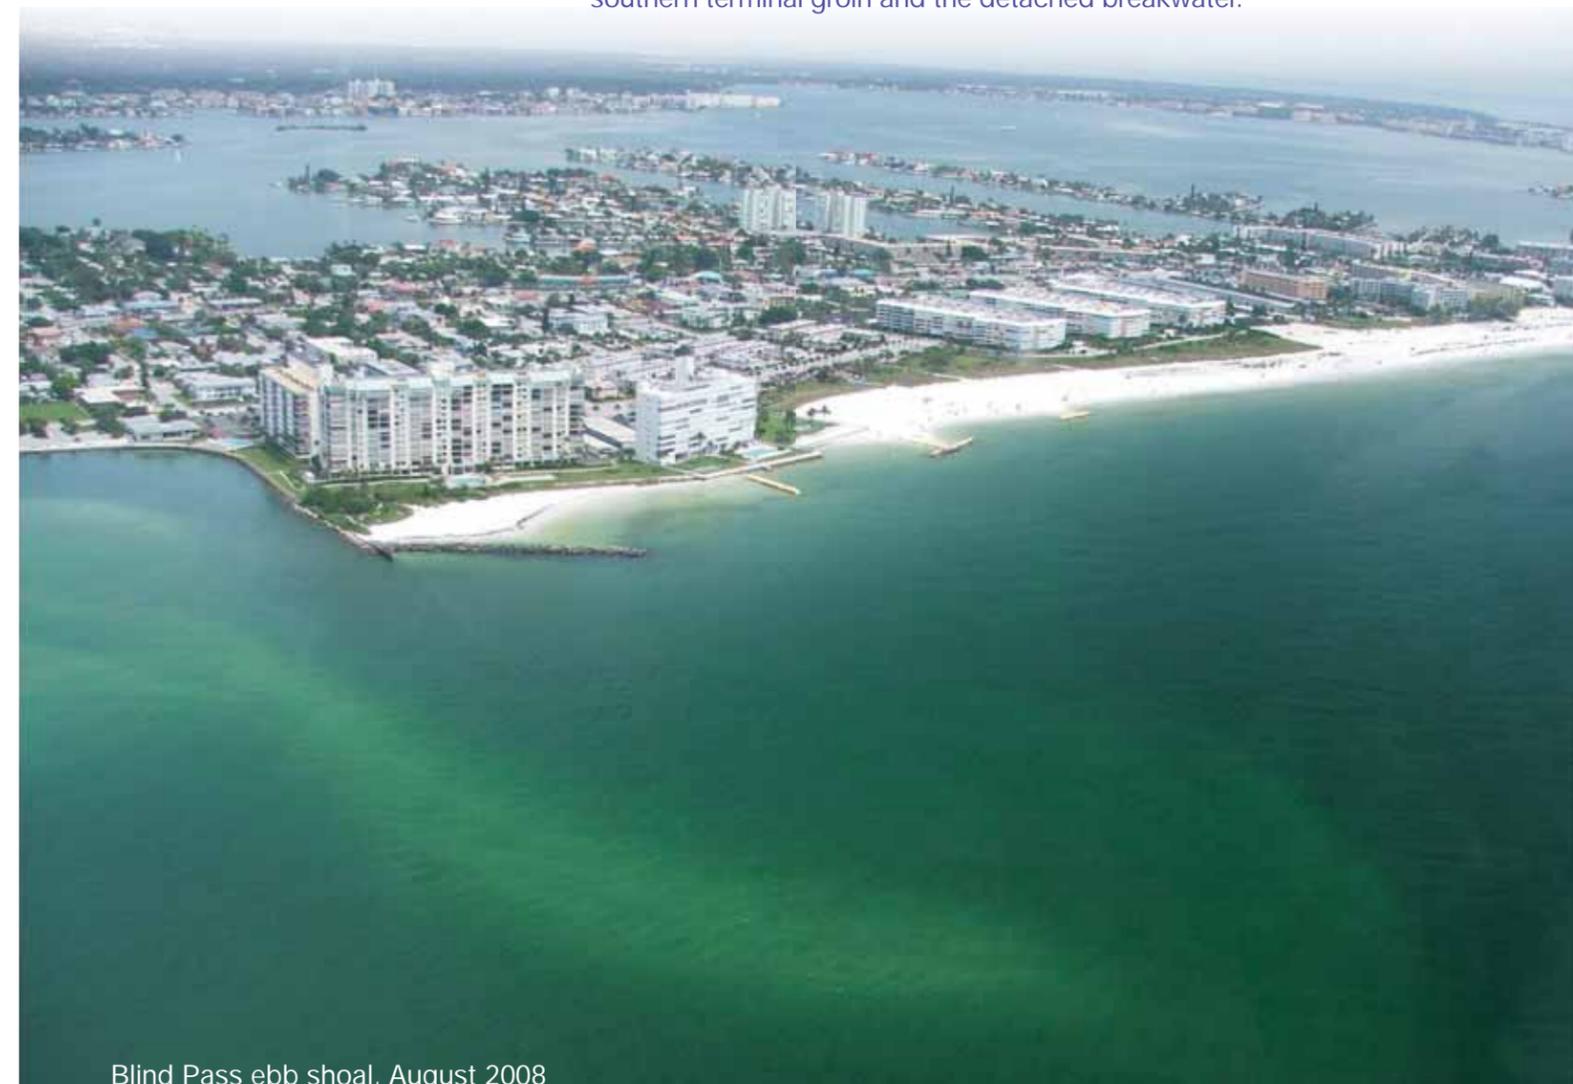
Blind Pass and Upham Beach in October 2003 depicting the stabilization of Blind Pass, the southern migration of the inlet and the development of the back-barrier bay. Photo taken prior to closure of the gap between the southern terminal groin and the detached breakwater.

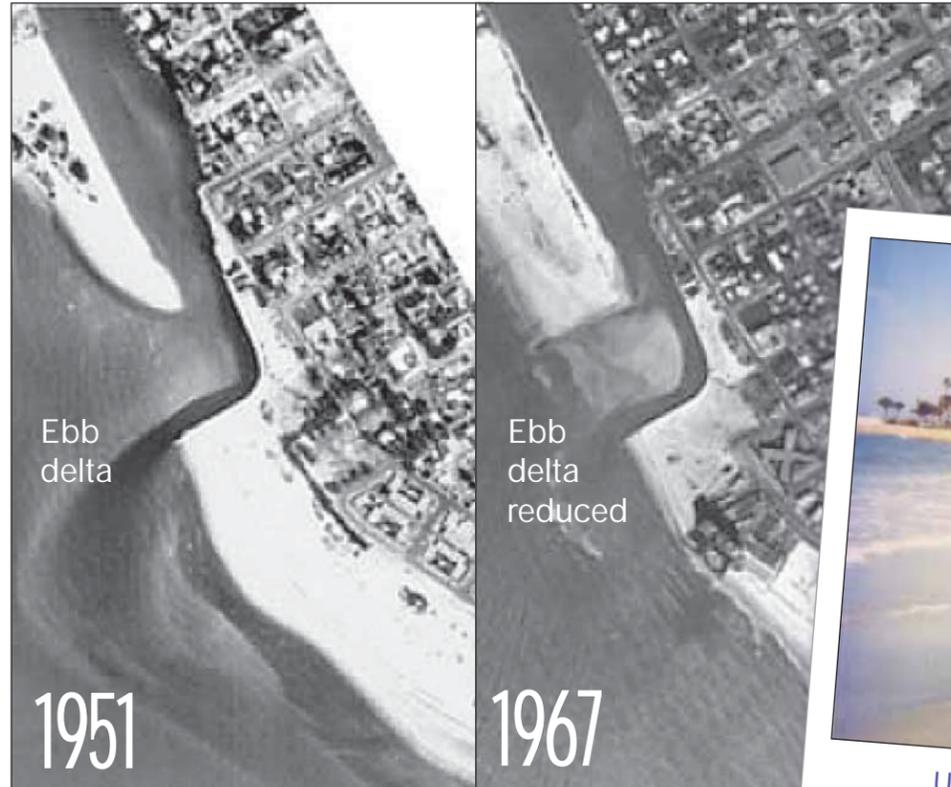
Ebb delta

Ebb delta reduced

This beach was privately owned by William W. Upham but was donated to local government in a possible act of foresight in 1954 and is now called Upham Beach. During the 1950s, Upham Beach was wide and stable due to onshore sediment transport as the ebb delta collapsed and migrated onshore. No coastal construction control line building regulations existed at the time and condos were built on the beach. Due to this poorly located construction, erosion problems were imminent. Once the sediment source from the collapsing ebb shoal disappeared, erosion began to plague this region.

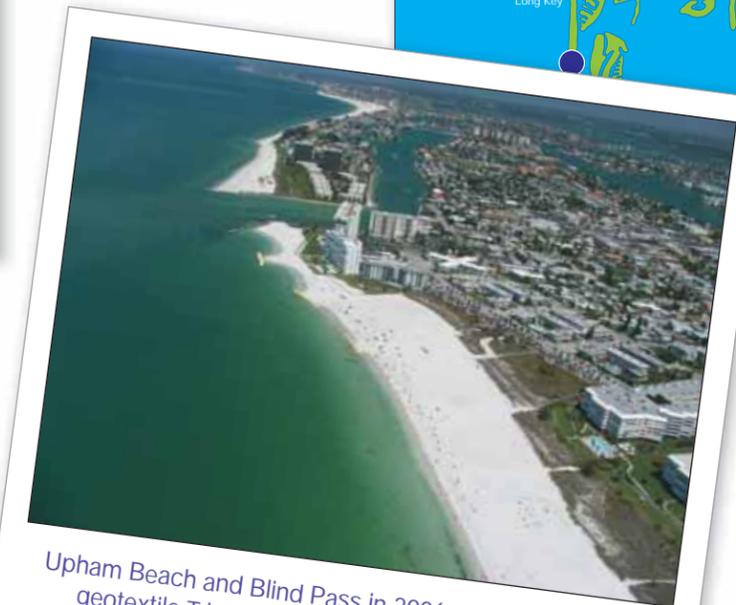
Upham Beach and Blind Pass in 2006 with newly installed geotextile T-head groins (erosion control structures)

The University of South Florida Geology Department has monitored the performance of the T-head groins since the 2006 renourishment project. From 2006 to 2008, Upham Beach lost nearly 40 percent less sand than during the same period of time following nourishment from 2000 to 2002 (Wang and Roberts, 2009). Based on 31 months of monthly monitoring, no negative impact from the T-head groin field to the downdrift beach has been identified. Thanks to the T-head groins, only 200,000 cubic yards of sand will be required for renourishment in 2009 thereby saving significant public funds.

Present length: five structures ranging from 100 to 310 feet long with 100- to 170-foot-long T-head groins

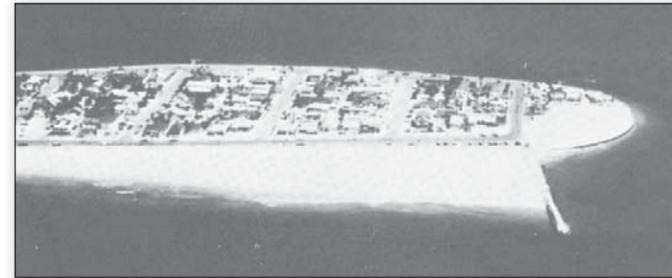
The terminal groin constructed at the south end of Long Key in 1965

Astonishing erosion occurred on Pass-a-Grille Beach in the 1940s and 50s. Historical postcards illustrate the total loss of a 500-foot-wide beach. In an effort to curb this erosion, the city constructed groins, a seawall and a terminal groin in 1965.

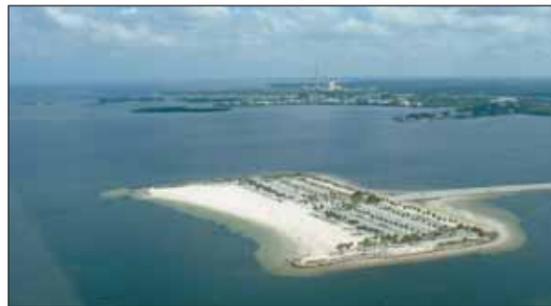
### Anclote Key

This barrier contains the Anclote Key State Preserve and the Anclote National Wildlife Refuge. Pinellas County does not manage the beaches of Anclote Key. Geologic studies indicate that Anclote Key is approximately 2,000 years old. This November 2005 photo looks north at the south end of Anclote Key.

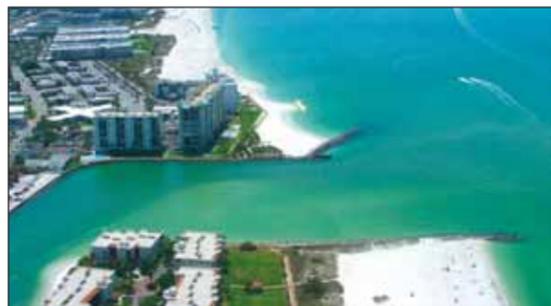
### Blind Pass

Blind Pass has more structural modifications than any inlet on the west-coast of Florida. The inlet is dredged periodically to nourish the downdrift beach (Upham Beach), most recently in 2000. The gap in the south breakwater was closed in 2005. The next dredging of Blind Pass is scheduled for 2009.

tidal regime of Blind Pass (Elko and Davis, 2006). The deterioration of Blind Pass was initiated by the hurricane of 1848 and then accelerated by anthropogenic influences. The large ebb tidal delta eroded, removing the sediment sink that caused the updrift end of the barrier to prograde (Davis, 1989). The shoreline now appears to be tending toward a straight configuration, as the island transforms from a drumstick barrier with a prograding updrift end and eroding downdrift end into a wave-dominated barrier with the opposite erosion/accretion pattern. The combined effect of terminal groins at Blind Pass, a minimal ebb shoal and periodic dredging of the inlet largely eliminated natural

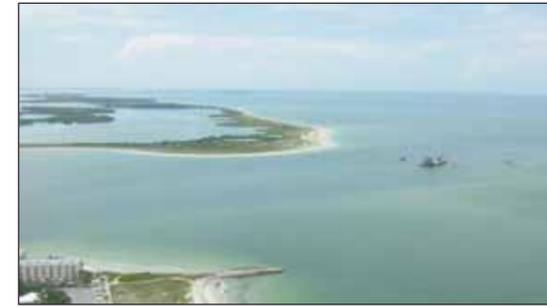
### Long Key

Long Key is the technical name for the island that contains the City of St. Pete Beach. The major erosional hot spot on Long Key is Upham Beach, on the north end of the island. Pass-a-Grille Beach, on southern Long Key, also requires periodic renourishment. The Pinellas County Beach Erosion Control program has maintained these beaches since 1980. Five geotextile T-head groins were installed on Upham Beach in 2005 as an experimental project intended to slow the rapid erosion.

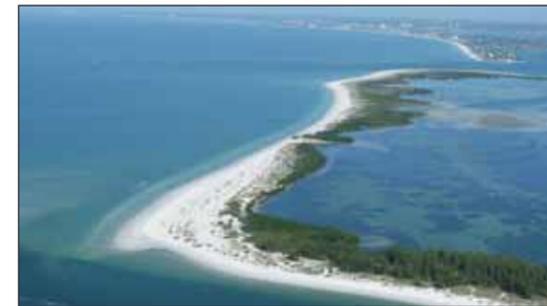
### Pass-a-Grille Channel

This inlet forms part of the Egmont Channel tidal delta complex. Modifications in the early 1960s to Pass-a-Grille Channel included dredging and the construction of the terminal groin and seawall at the south end of Long Key. Dredged material from Pass-a-Grille Channel was placed on Long Key in 1986 and 2004.

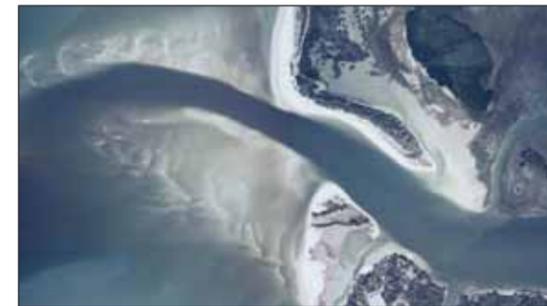
### Shell Key

Shell Key began as two separate sand shoals that have built up and merged since the 1950s. The island is now managed by Pinellas County's Department of Environmental Management. This photo looks north in November 2005.

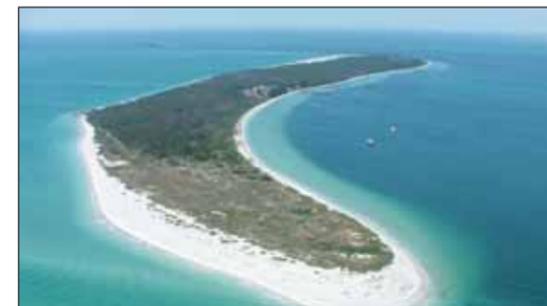
### Mullet Key

The barrier island containing Pinellas County's Fort De Soto Park has a right-angle formation with one shoreline exposed to the Gulf of Mexico and the other shoreline exposed to Egmont Channel. A restoration project was constructed in 2006 that involved placement of beneficial-use material from the dredging of the Tampa Bay shipping channel. The L-shaped terminal groin, originally built in the 1960s, was also rehabilitated. This photo looks north along the Gulf of Mexico of Mullet Key shoreline in April 2006.
