# Beckett Bridge PD&E Study

## Rehabilitation Alternative (No Widening)

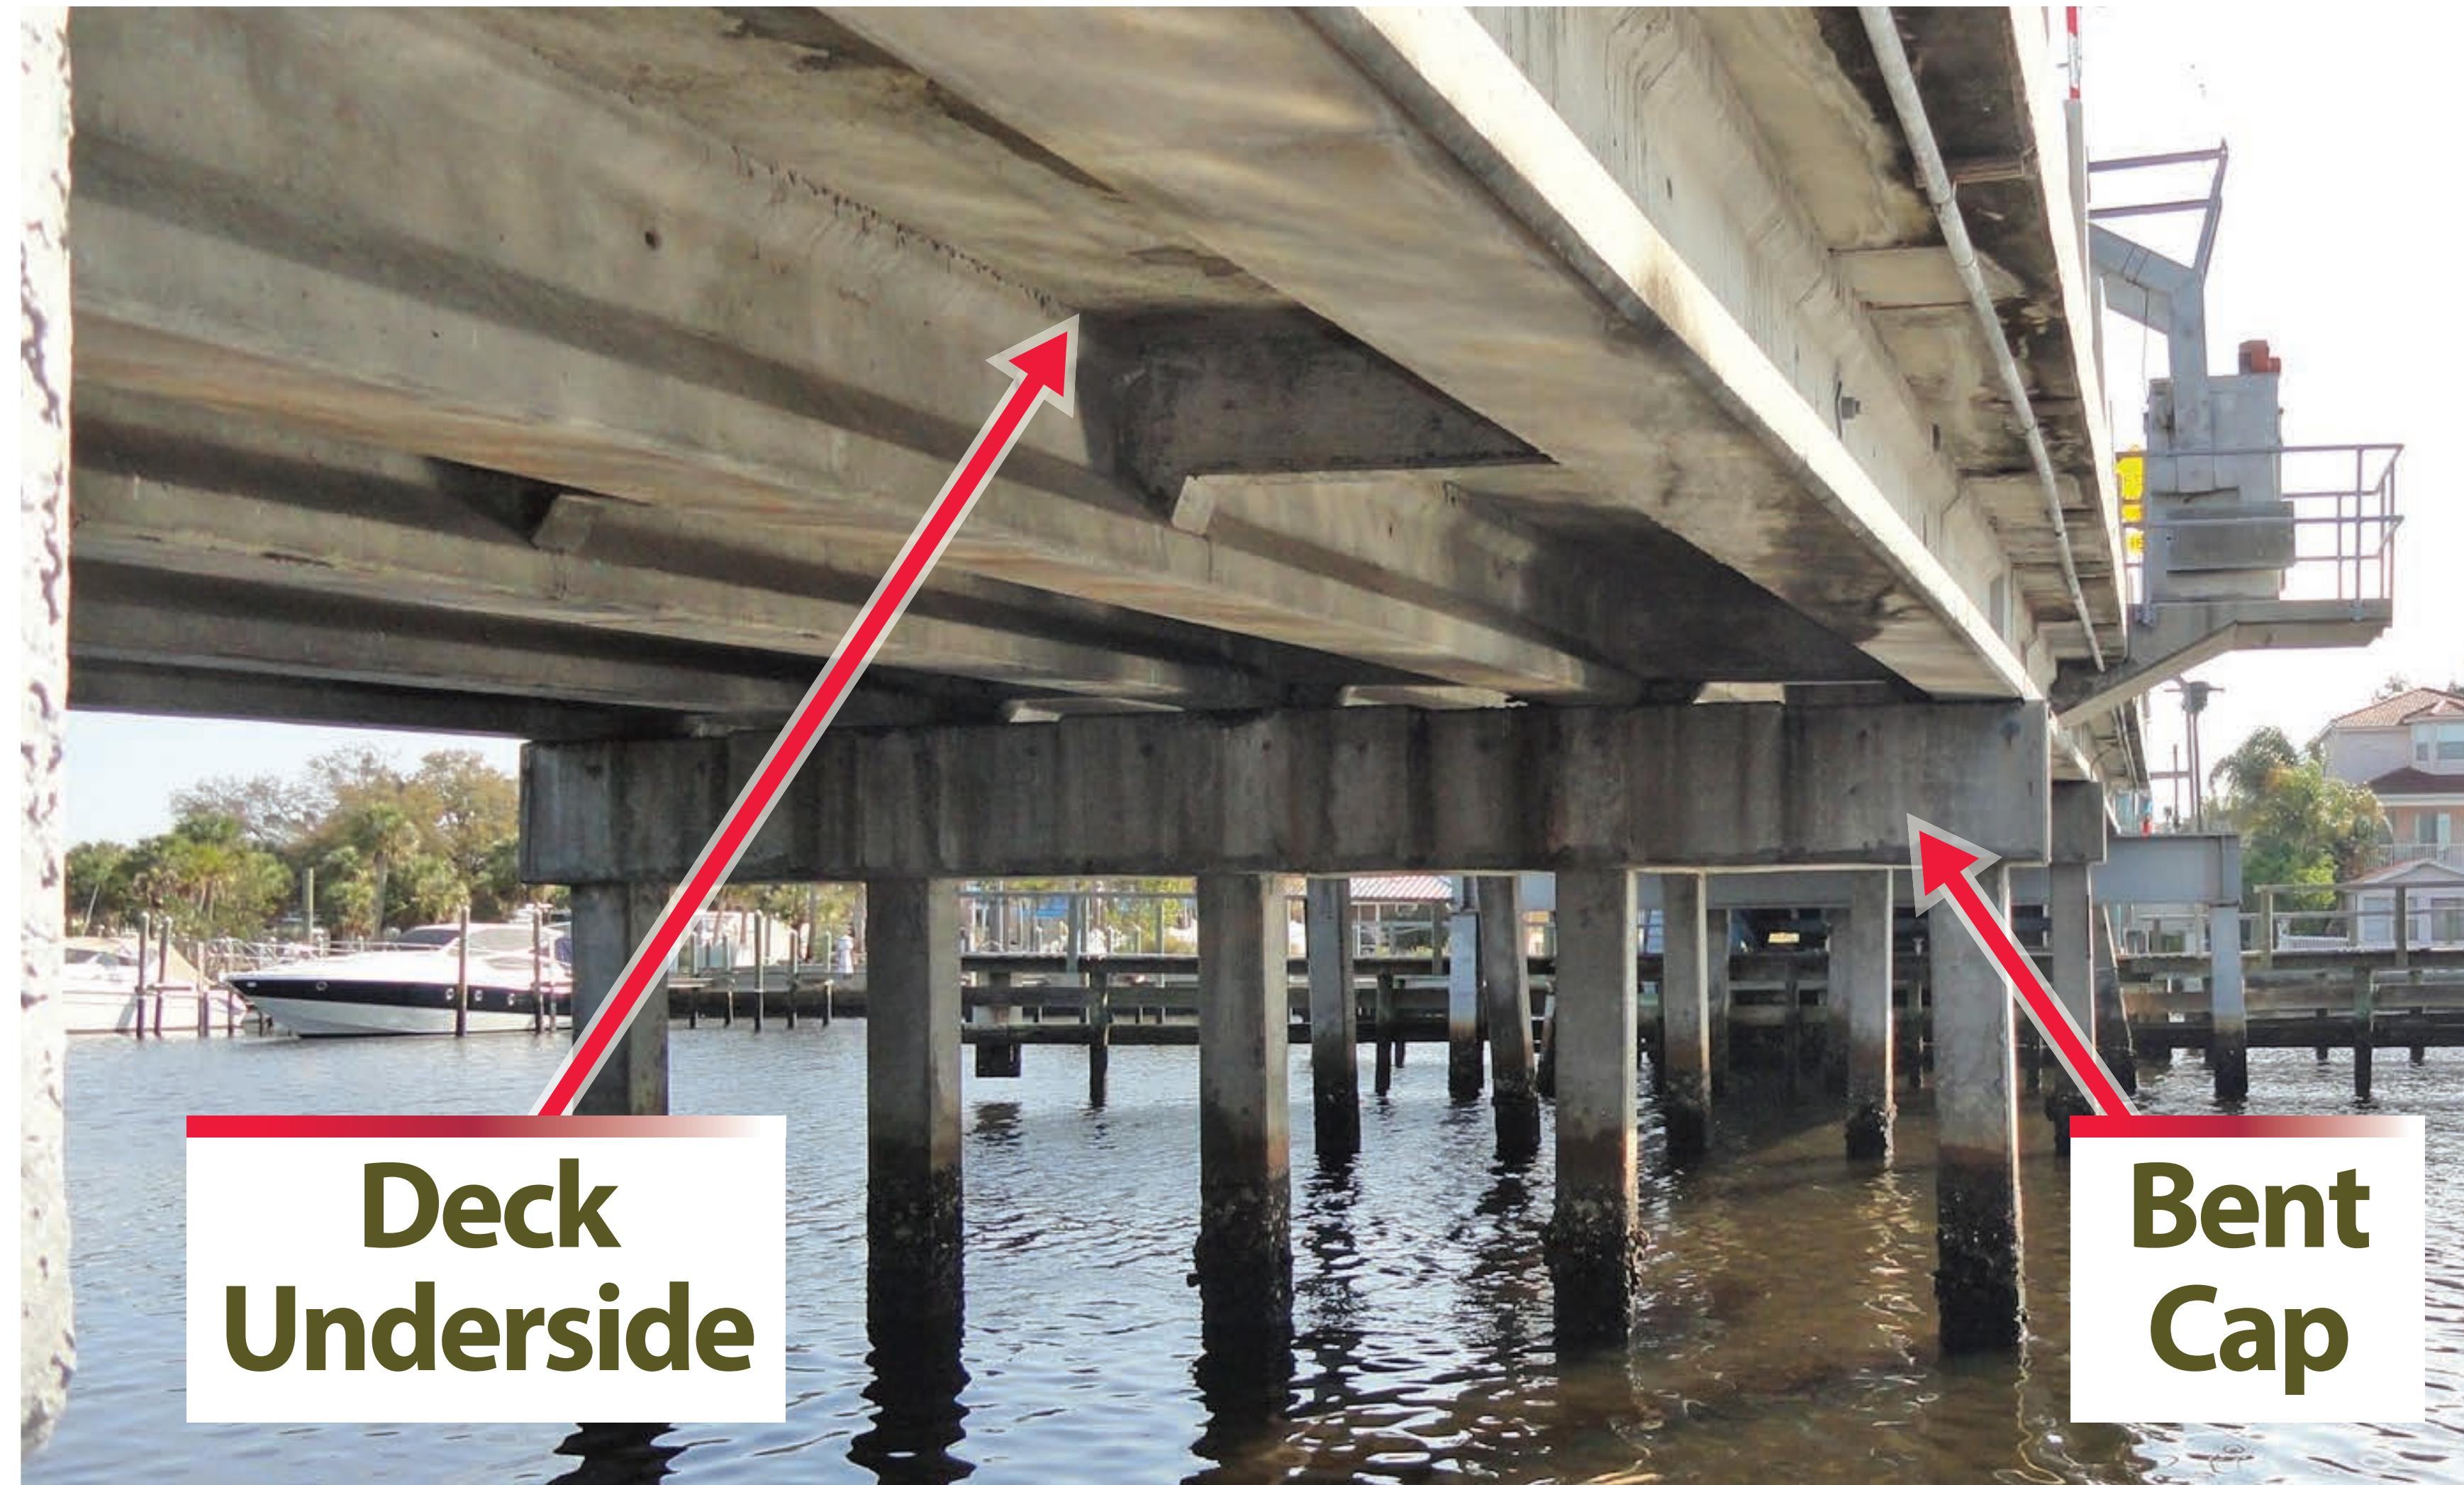
- Repair deteriorated concrete deck underside and provide cathodic (corrosion) protection
- Repair deteriorated concrete of pile bent caps and provide cathodic (corrosion) protection

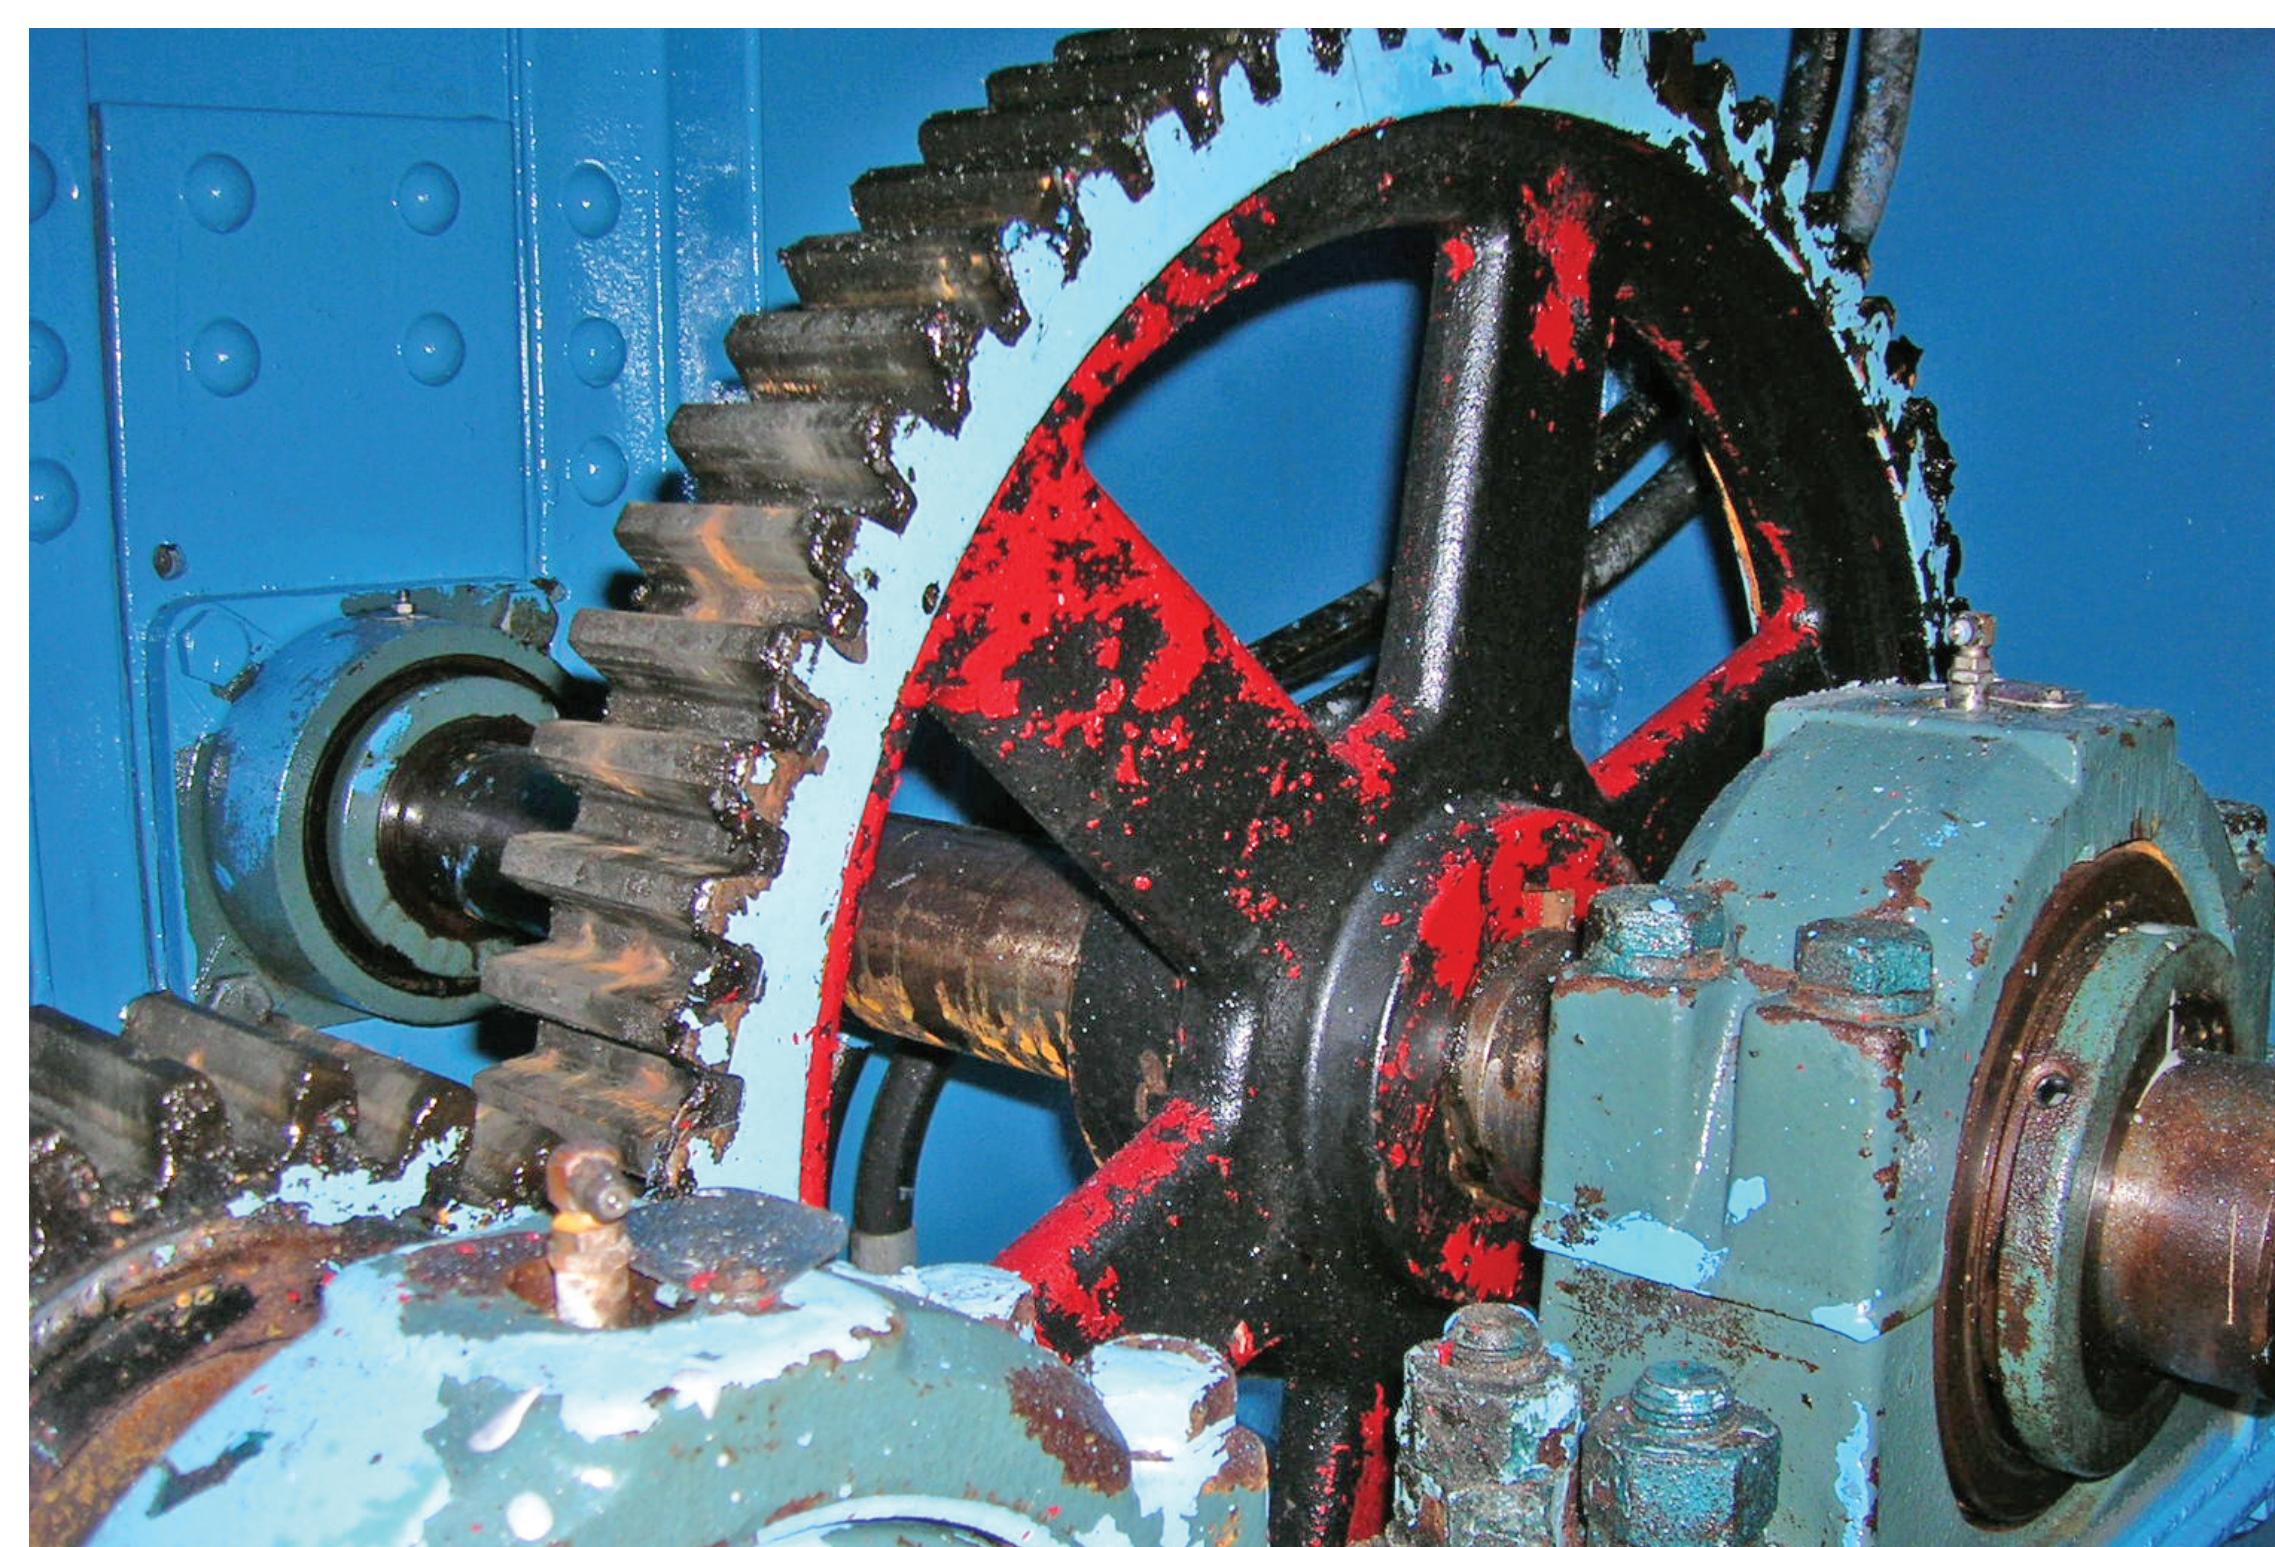
- Replace electrical systems and machinery

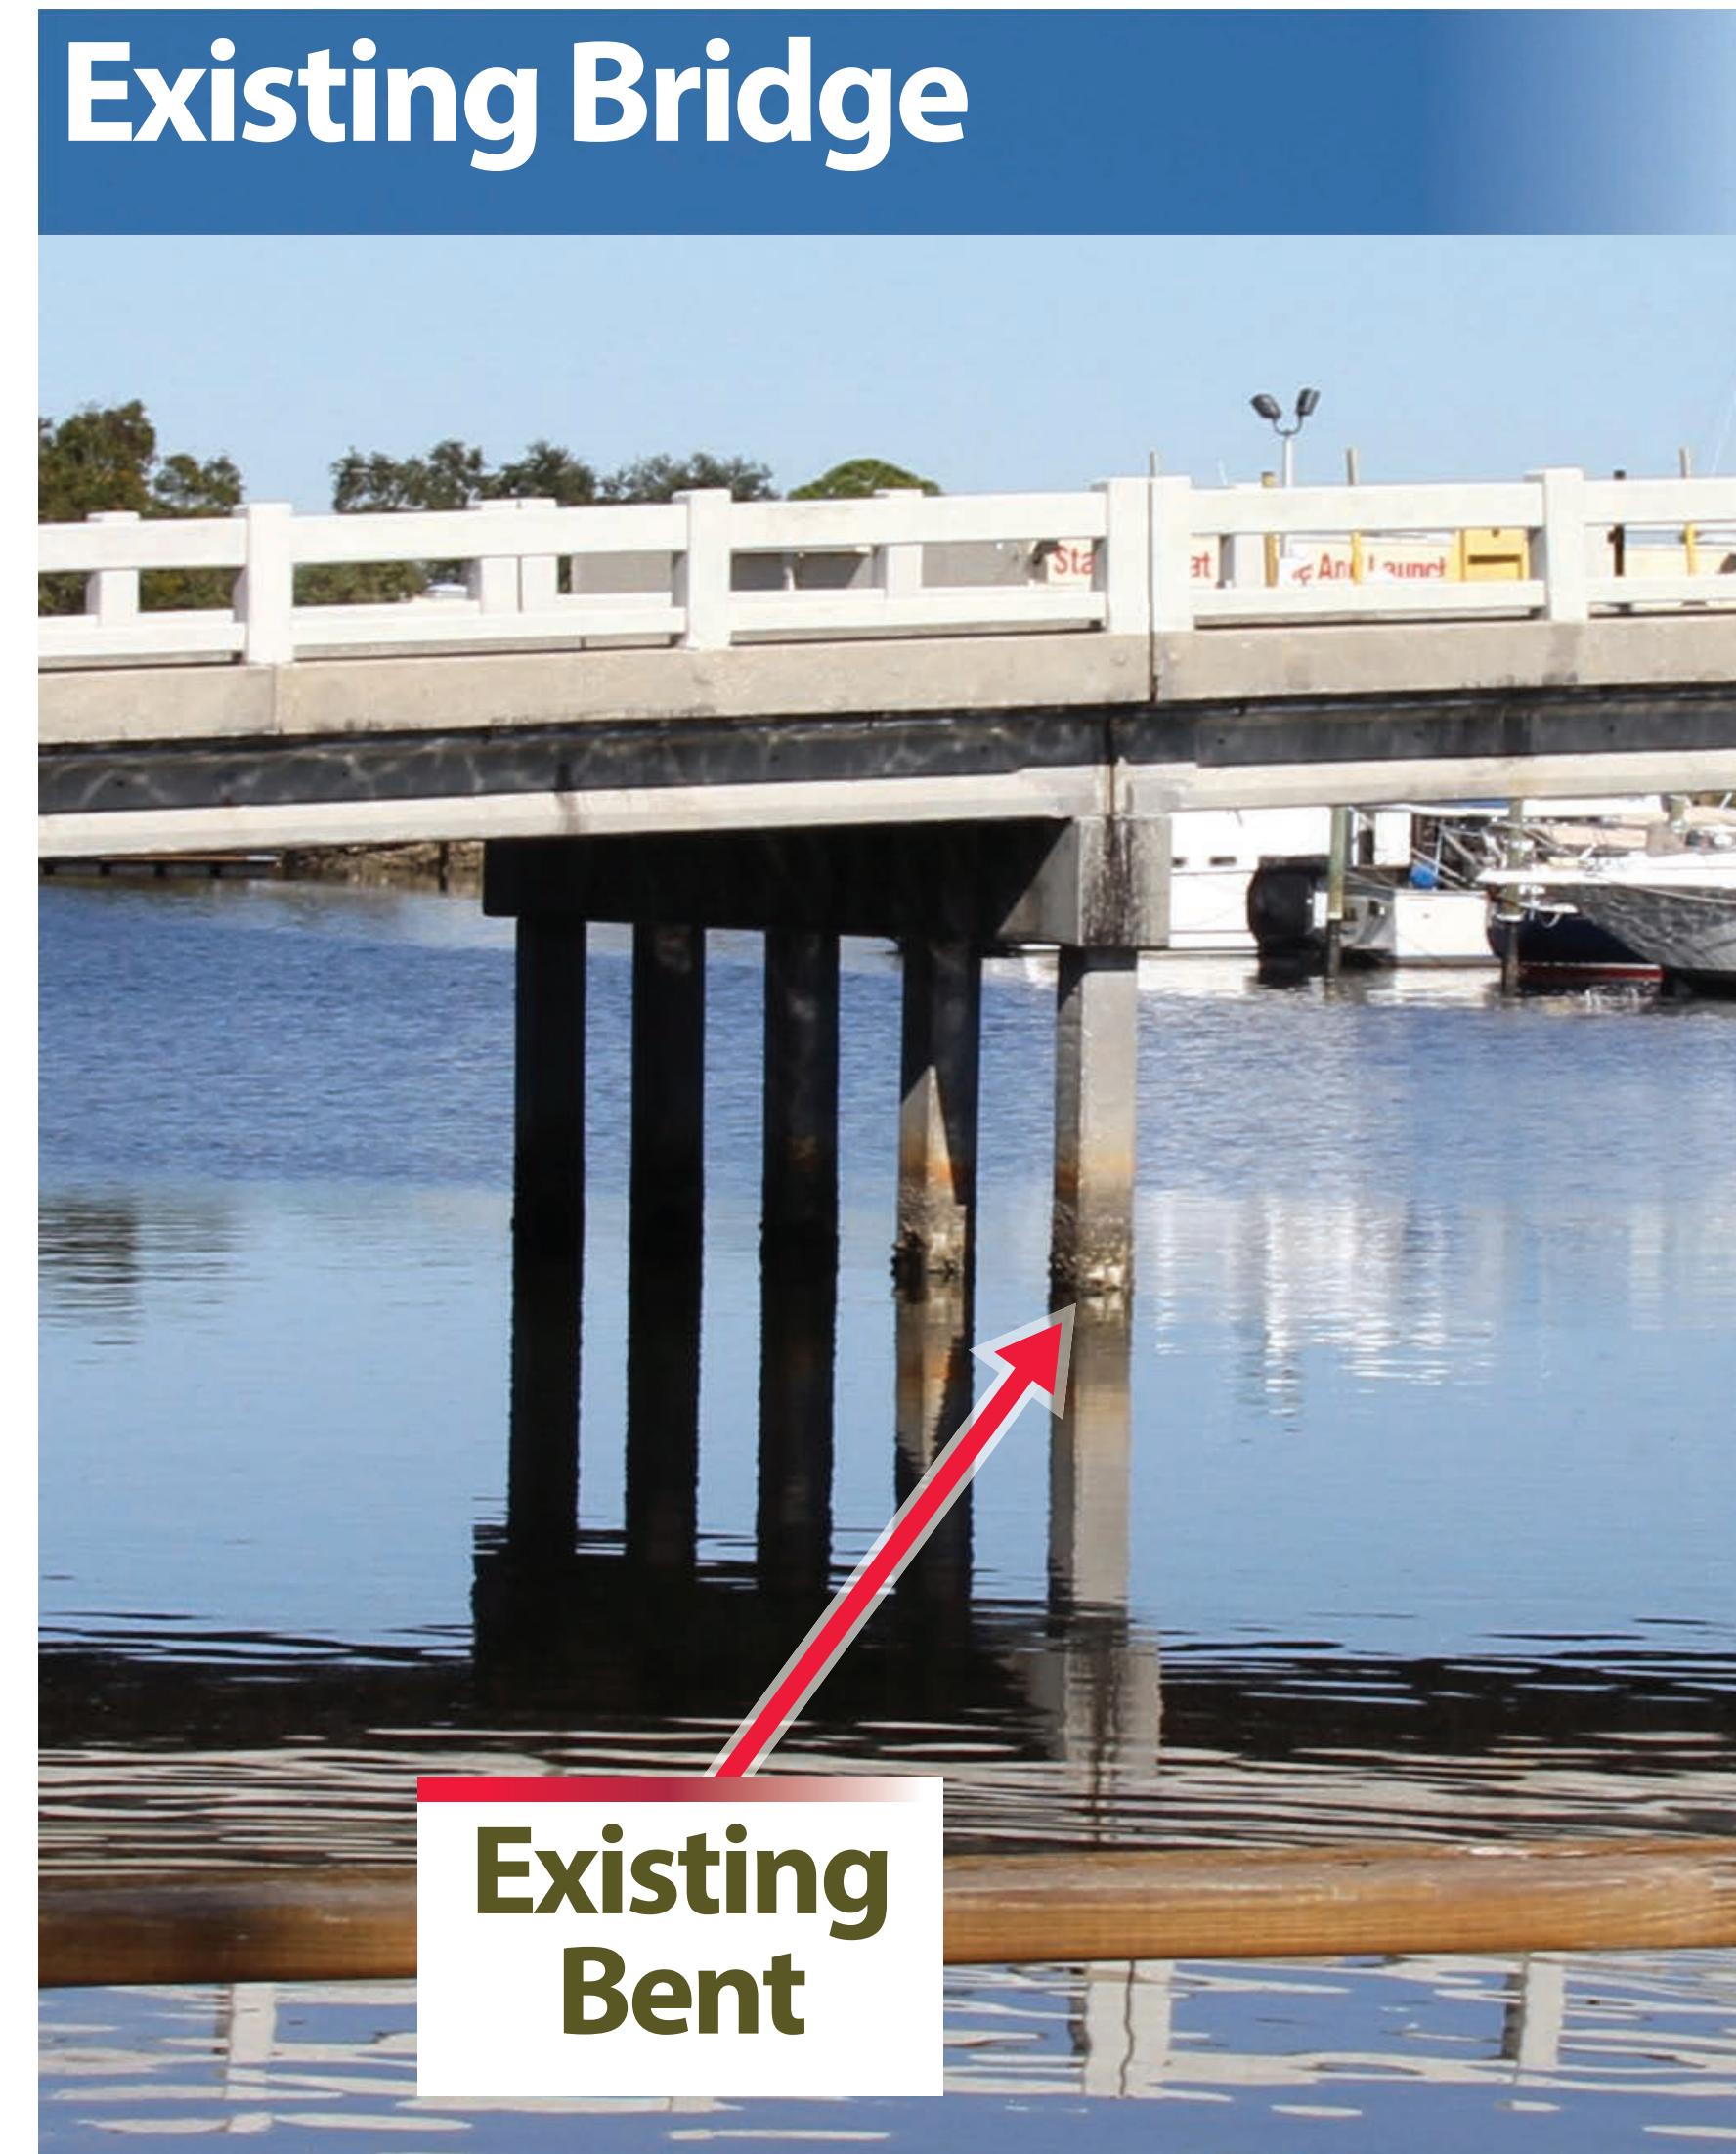
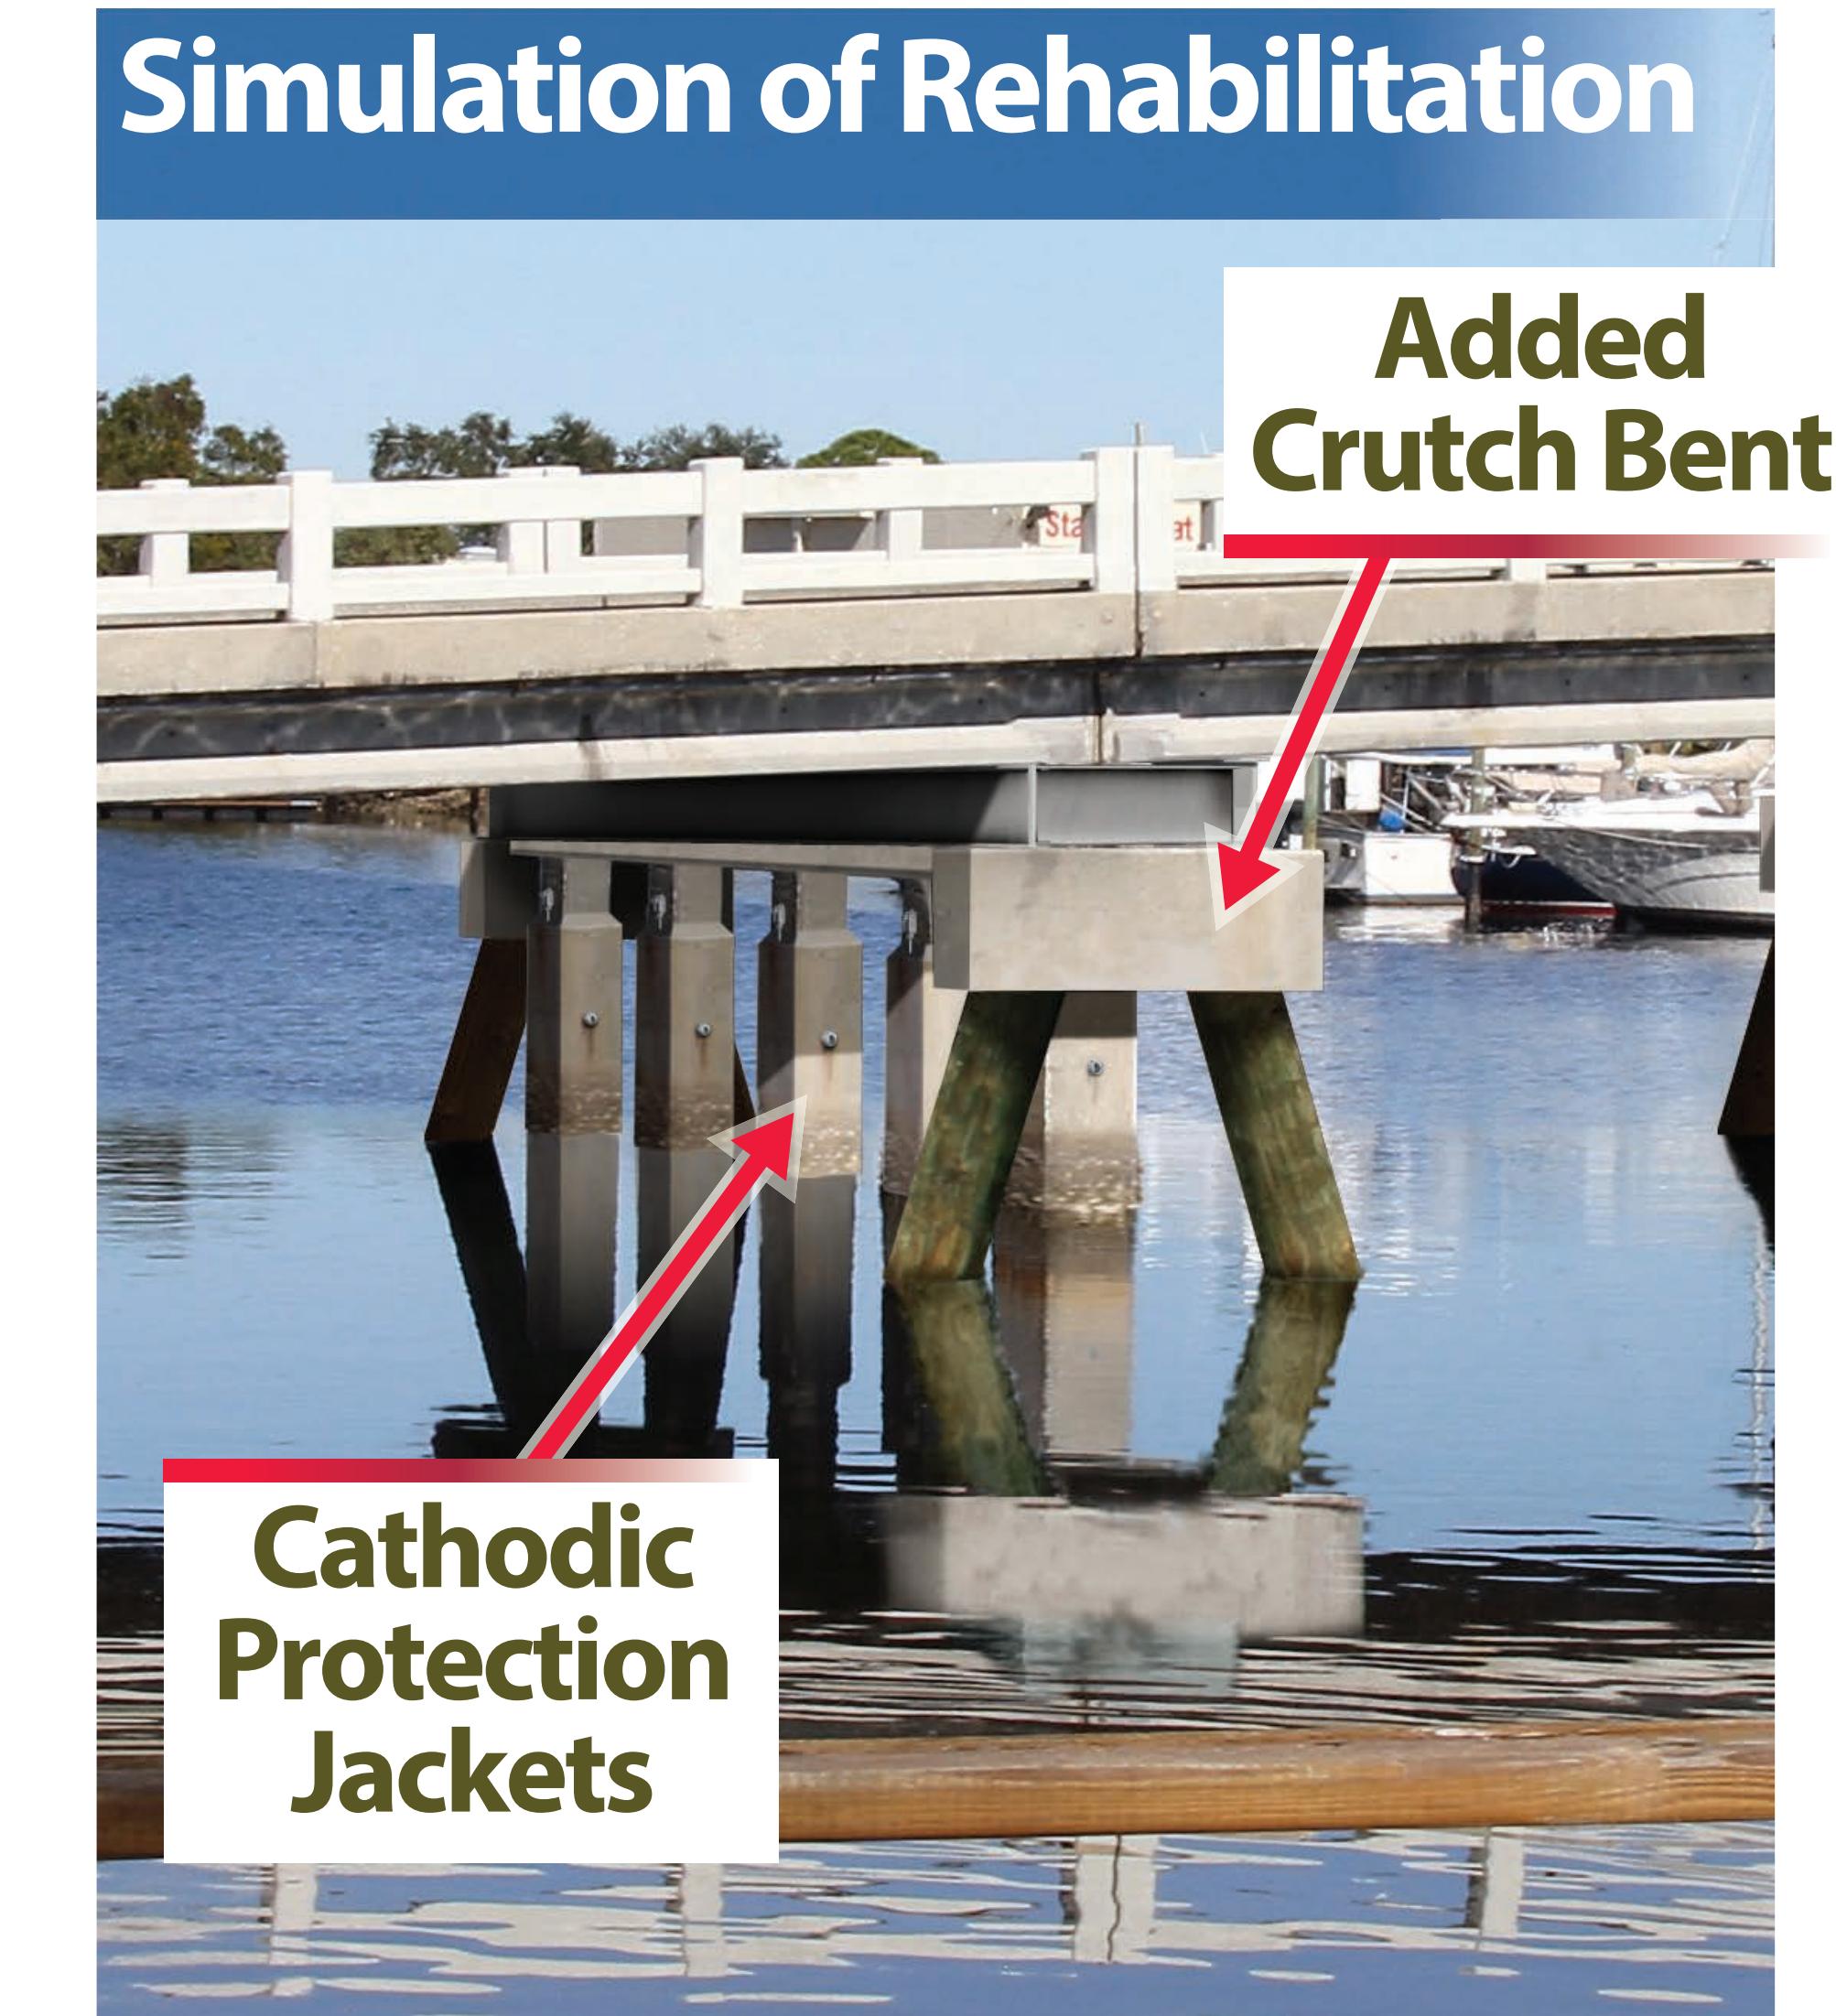
- Install crutch bents at Bents 2, 3, 4, 5, 9, 10
- Install new cathodic (corrosion) protection jackets on all concrete bent piles
