Honeymoon Island Coastal Management History

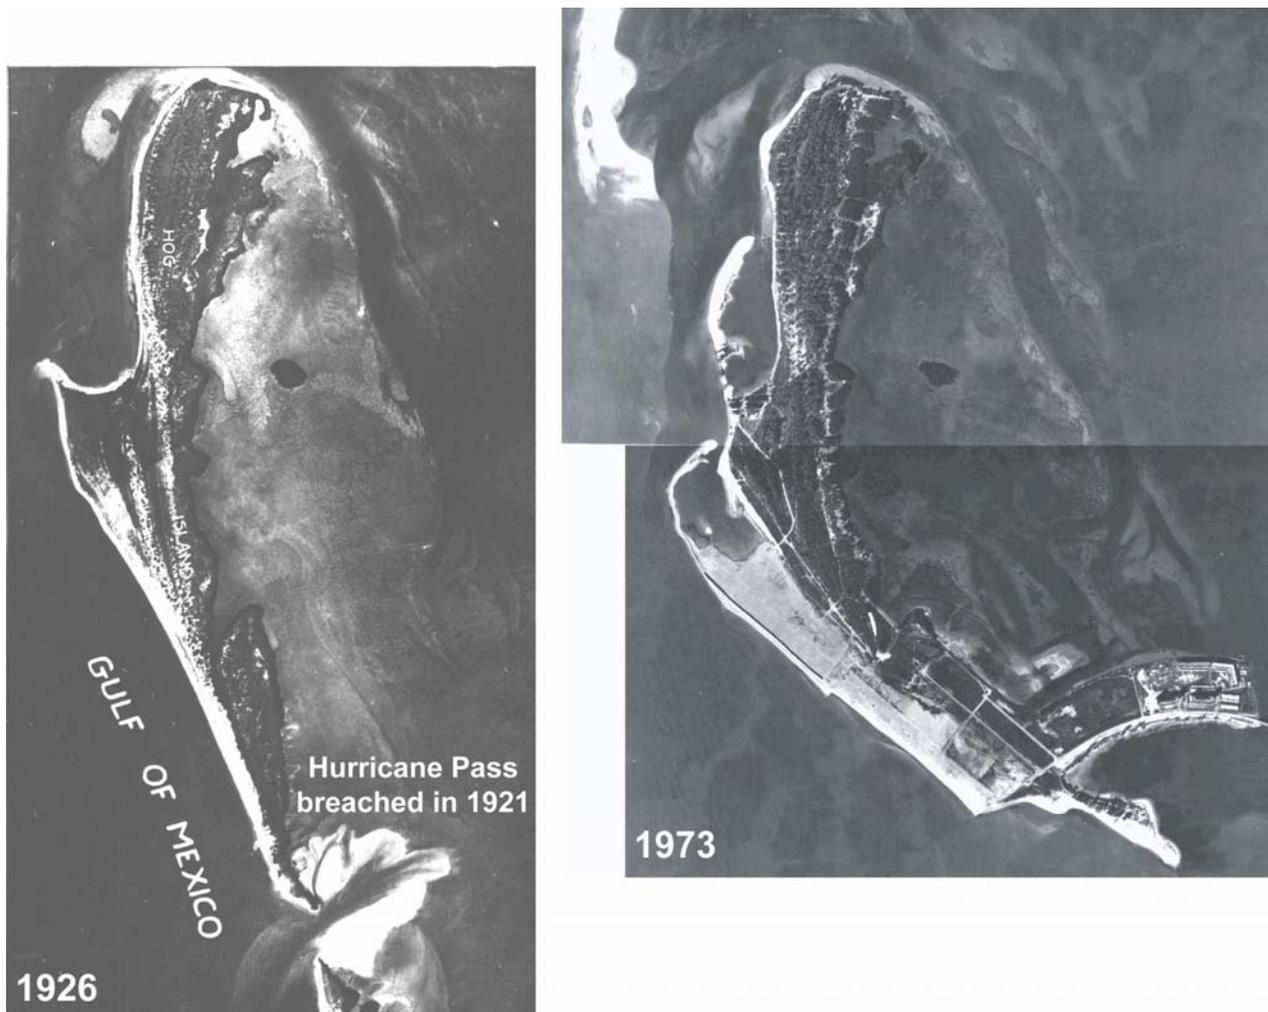
Honeymoon Island and Caladesi Island were connected as one barrier, known as Hog Island, prior to 1921. The Hurricane of 1921 breached the island in the center, creating Hurricane Pass and the two separate islands.

Honeymoon Island went through the hands of several developers in the early 1900's. The last owner was responsible for the most dramatic morphologic modification to any barrier island in Pinellas County. The developer dredged material from the nearshore and pumped over 1 million cubic yards of rocky fill onshore. The historic photos illustrate that from 1926 to 1973, the size of the island was nearly doubled and the shoreline orientation changed by more 10 degrees.

The Florida State Park system acquired island in 1974 and constructed many of the park facilities, including parking lots and bathhouses, along the newly created western shoreline. The unnatural shoreline orientation has resulted in beach erosion and exposure of a rocky coastline. A phased coastal management plan has recently been developed to maintain a sandy beach along the central island shoreline. The Honeymoon Island Beach Restoration Project Phase I was constructed in late 2007.
